HISTORIC STRUCTURES REPORT

PANAMA HOTEL

HASHIDATE YU BATHHOUSE &
JAPANESE-AMERICAN COLLECTIONS

Published June 18, 2014.

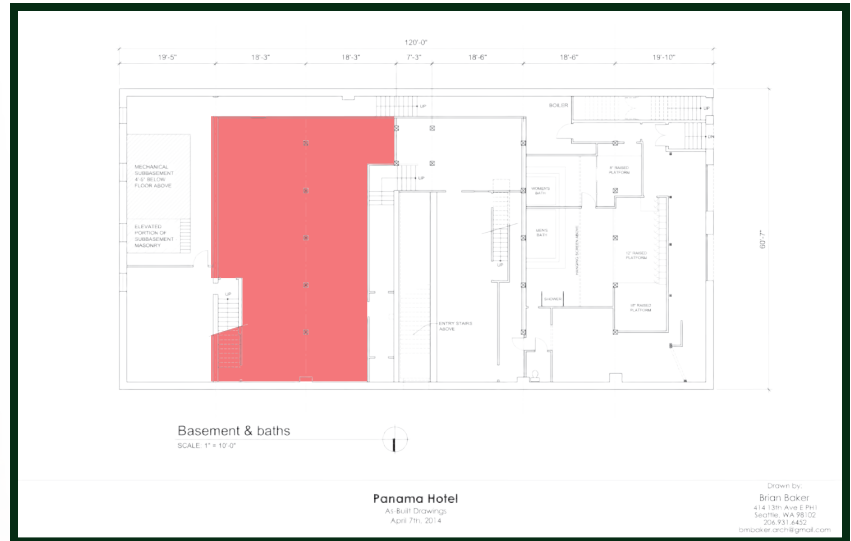
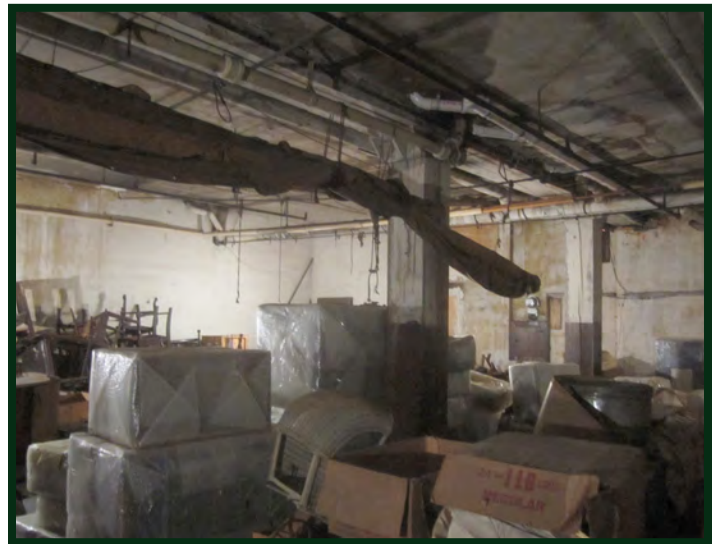
- Poor condition overall
- Several areas of ceiling loss due to water infiltration

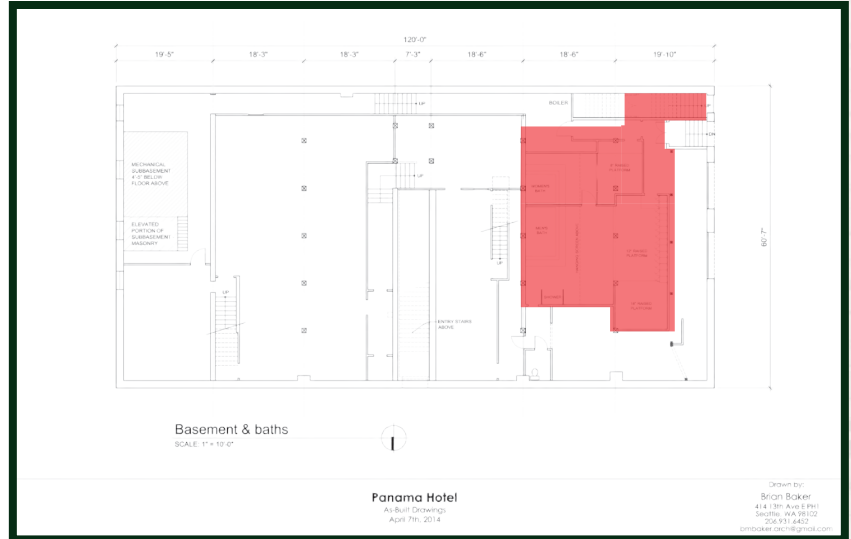
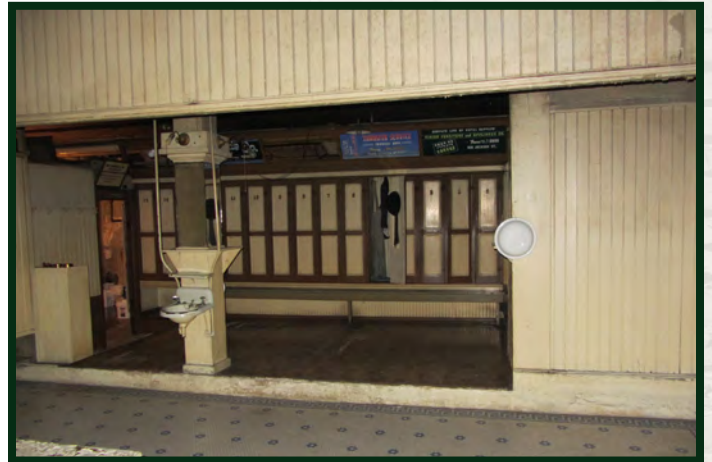
- Overall fair condition
- Moderate paint deterioration and loss
- General soiling, particularly at upper ceiling and wall surfaces
- Notable pitting and wear along surface of marble at bath, this is part of the character of the bath and should not be changed, much of this pitting is already evident by 1944, as seen in a September 24, 1944 Seattle Times photograph

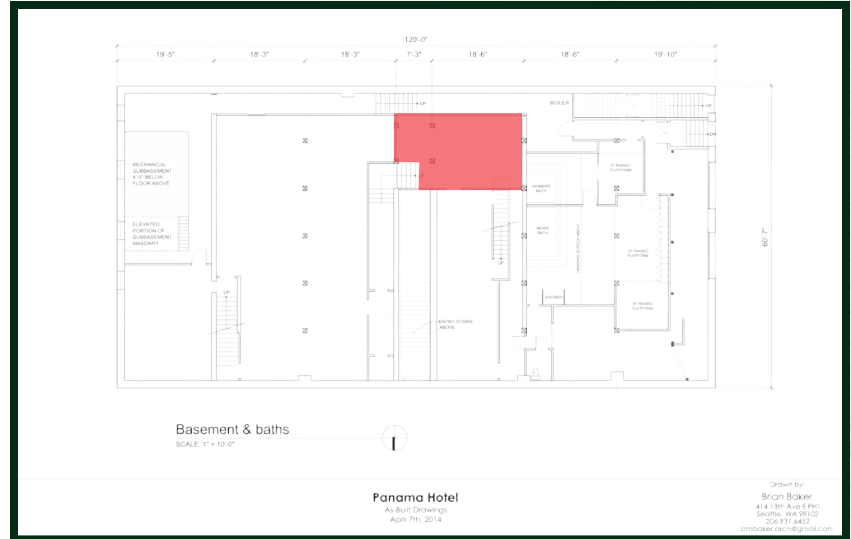
STORAGE C

- Overall fair condition

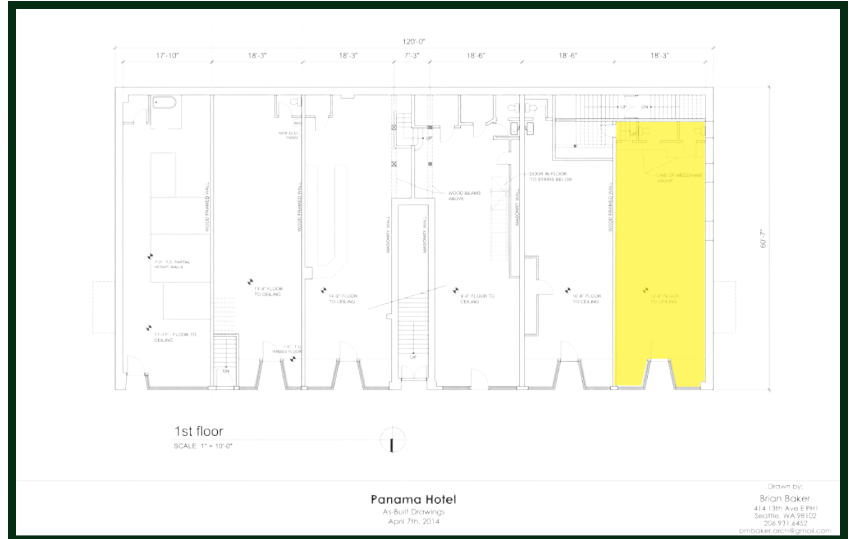
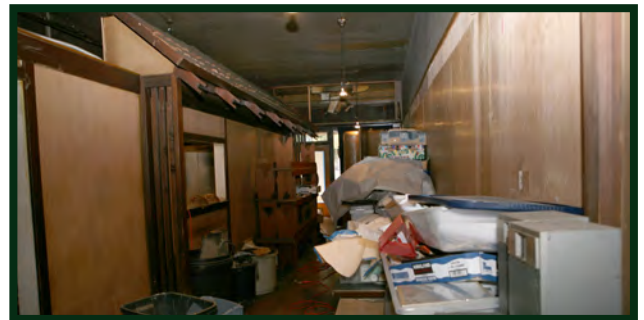
- Extensive soiling and some floor deterioration due to kitchen operation
- Missing putty at door transom
- Deteriorated door threshold
- Cracked tiles at southwest corner of tile floor
- Missing sections of ceiling plaster and lath

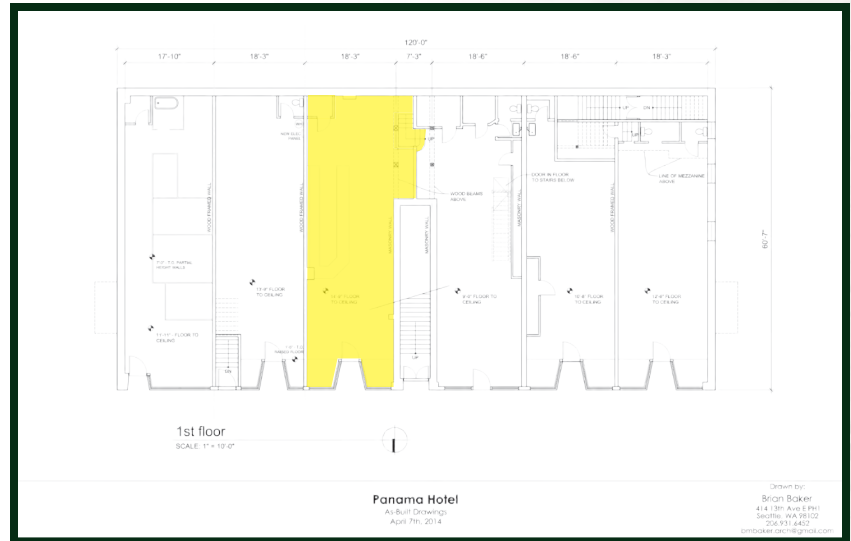
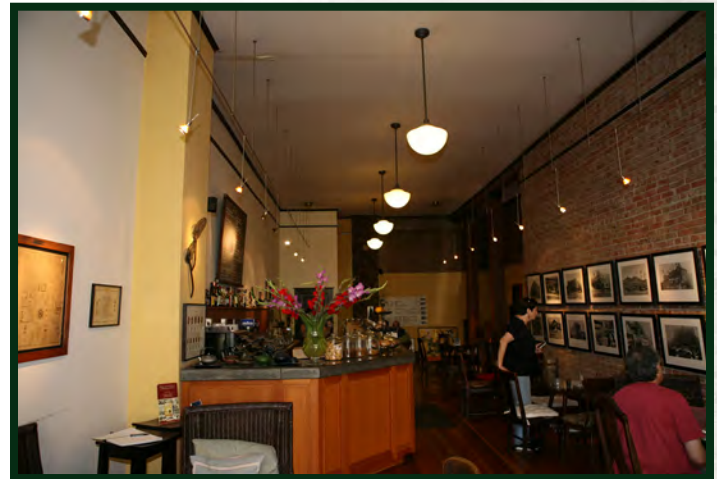
- Transom intact, but weathered
- Weathered or missing brick mold
- Nails in brick mold

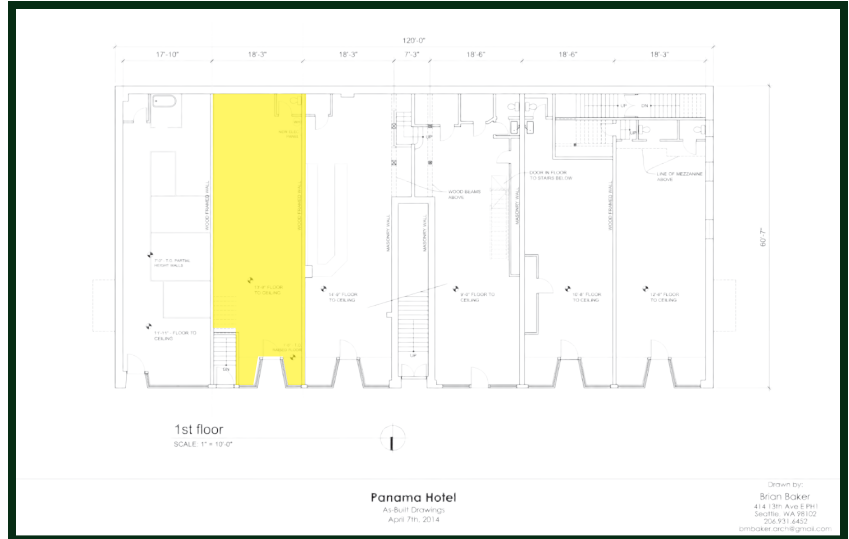
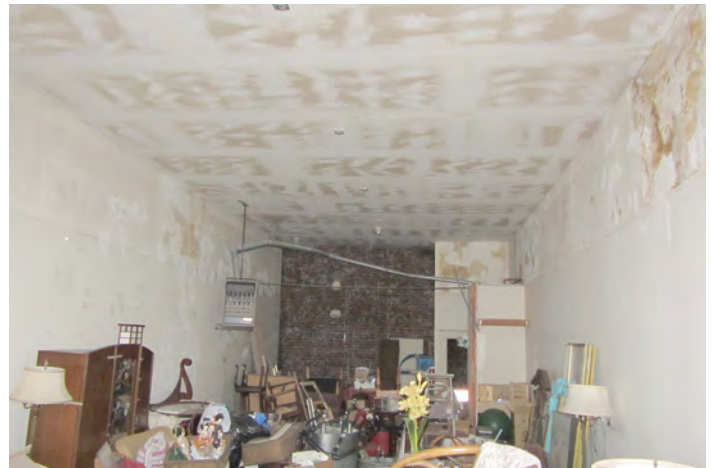
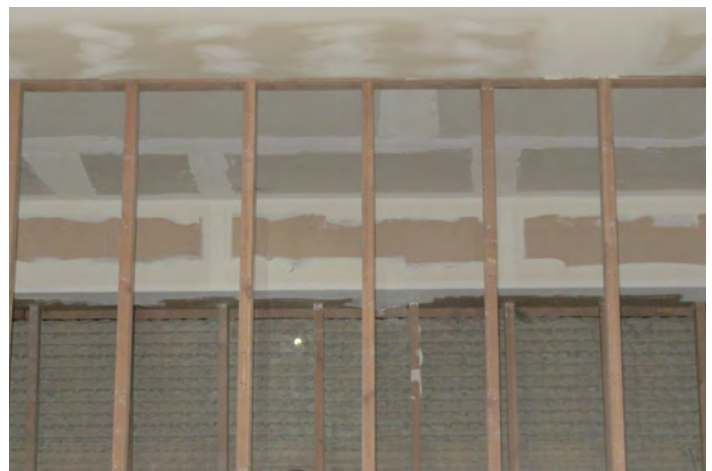
611 SOUTH MAIN STREET

- Overall fair condition
- Water damage evident along the ceiling from overflowing sinks in the hotel rooms above
- Extensive stored items within the space that appear to be contemporary items

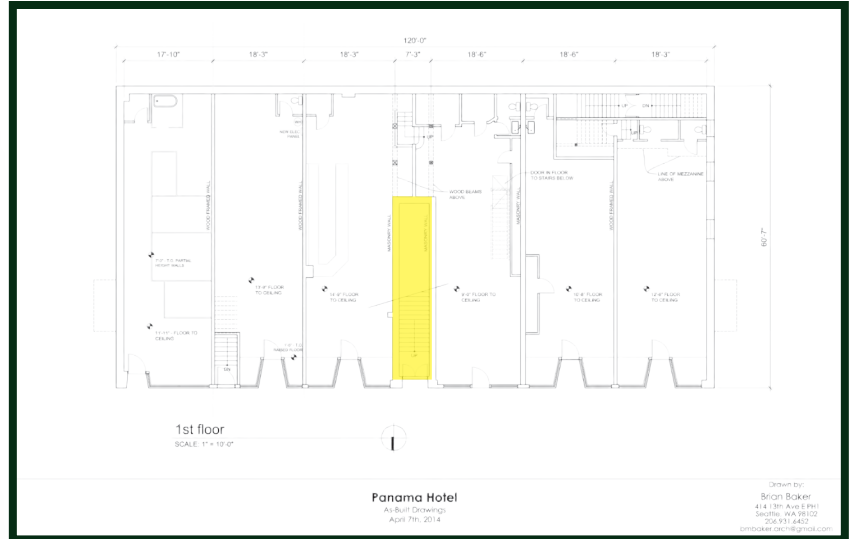
- Cracking in tiles
- Moderate deterioration

- Chips and scratched in tiles
- Some dents in railings
- Stairs, 3/4-inch settlement between carriage and tile wainscot
- Slight water damage to the curved metal awning

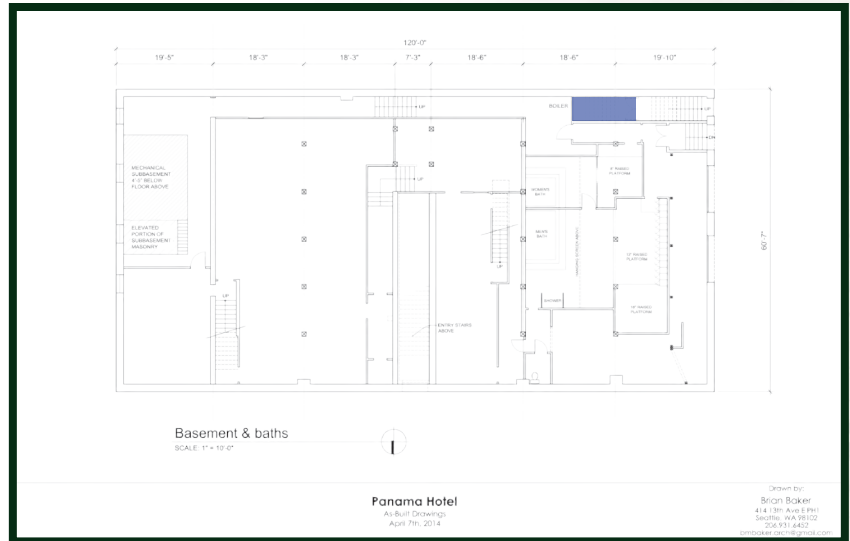
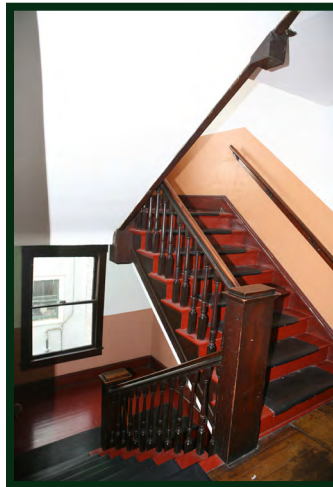
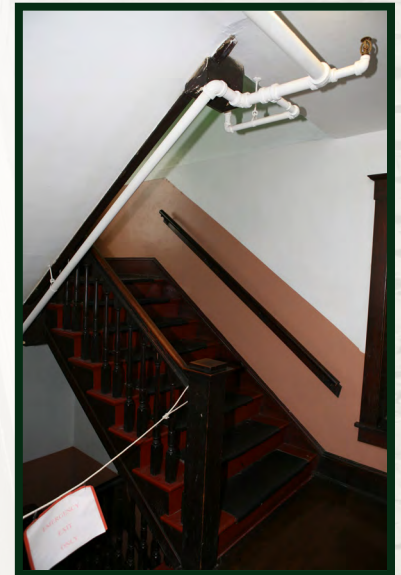
- Overall fair condition
- Separation of carriage from masonry wall along south side

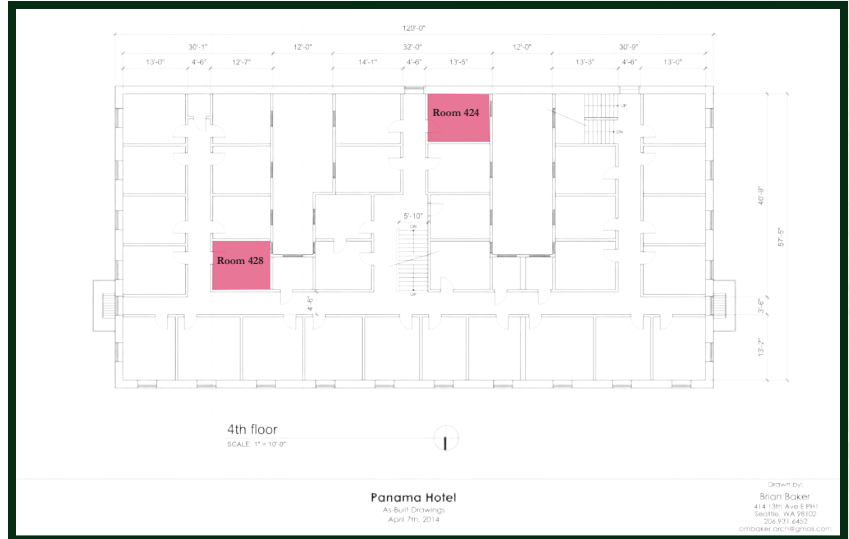
- Missing wood stove (at chimney chase)
- Floor settlement (separating from south exterior masonry wall by at least an inch)
- Furnishings that are potentially significant:
 - Metal bed
 - Wood vanity
 - Square top, scroll leg table
 - Non-historic footstool
 - Medicine cabinet
