# MITCHELL PARK HORTICULTURAL CONSERVATORY DOMES Peer Review

## **Final Report**

March 14, 2017

WJE No. 2016.2700

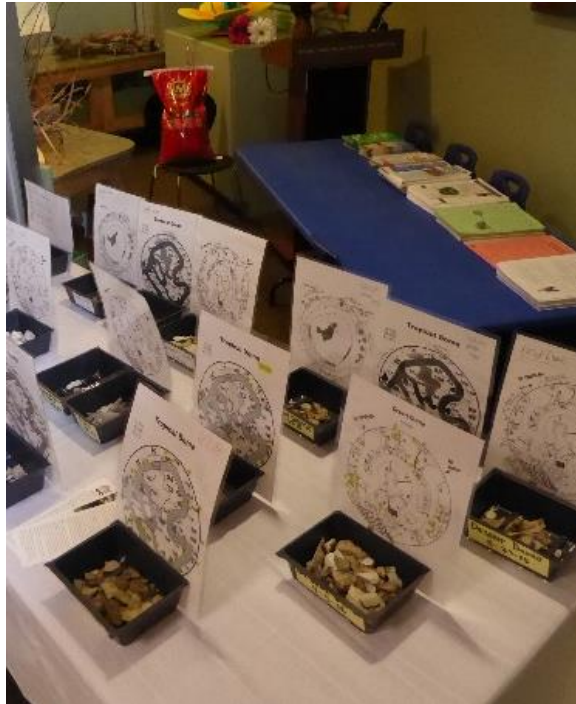
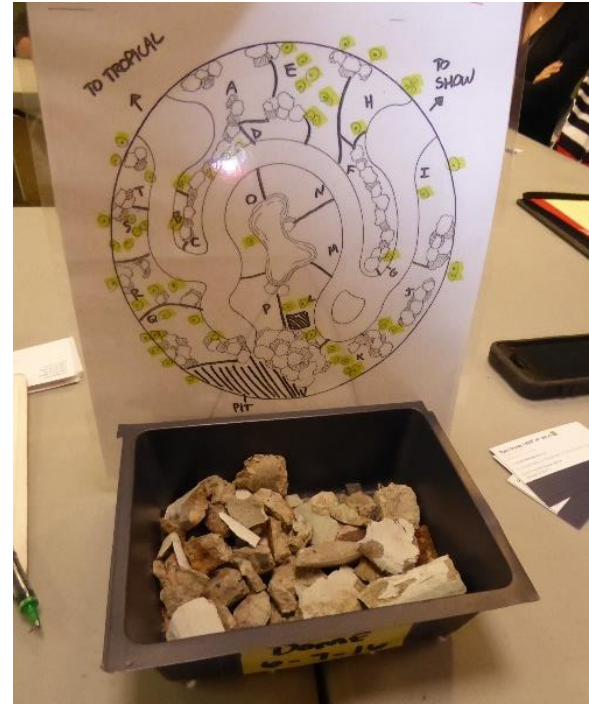
Figure 10. Fragments of concrete collected by Milwaukee County Parks staff

Figure 11. Close-up of fragments of concrete collected by Milwaukee County Parks staff

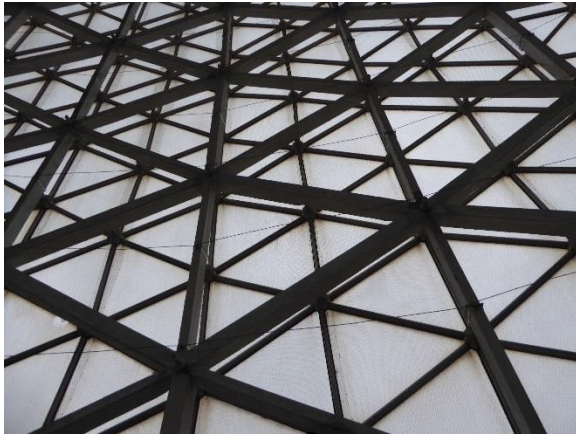
1. Mesh netting secured to the precast framing with cables was observed in the Show Dome (Figures 12 and 13). The netting was in the process of being installed in the Arid Dome.

Figure 12. Netting and cables in Show Dome

Figure 13. Close-up of netting in Show Dome

- The wire mesh could be removed after the repairs are completed to address water infiltration and spalling at embedded plates. Removing the wire mesh would require regular inspections and maintenance repairs to be completed as necessary. However, the mesh does provide a safety barrier against spalling concrete that has occurred in the domes.

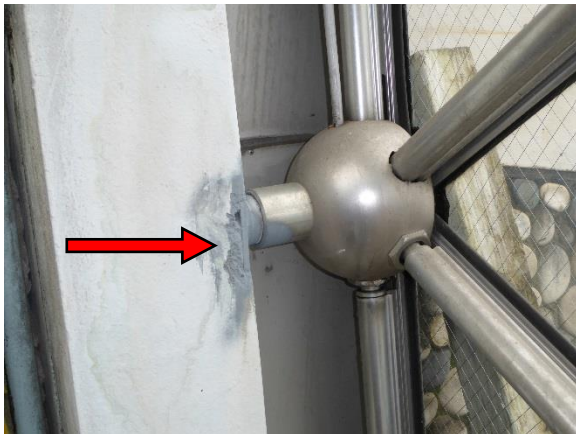
3. Concrete spalls had been removed at several embedded connections where the hub from the glass cladding is supported by the precast framing (Figures 14 and 15). The embedded plate was painted at the location of removed spalls.

Figure 14. Removed spall at connection location. Note: connection is painted with blue colored coating.

Figure 15. Removed spall at connection location. Note: connection is painted with blue colored coating.

1. Remove delaminated concrete at embedded plates, and clean and paint the plates. Proactively removing potential spalls at connection plates could be performed, but may not be necessary if the netting remains in place. If removing the netting is desirable, we recommend proactively removing potential spalls at embedded connections.
2. Repair concrete spalls with exposed reinforcing steel within the body of the precast member.
3. Repair deteriorated areas of grout.
4. Clean and paint the concrete with a coating system capable of bridging over cracks. Some cracks and joints may need to be stripe coated or sealed prior to the coating installation.

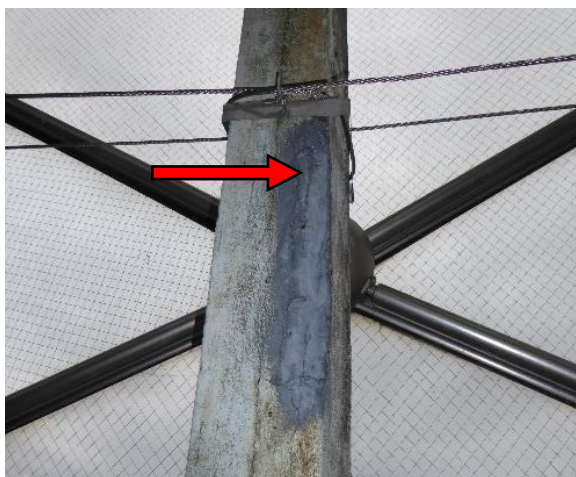
4. Concrete spalls, previously removed, were observed within the body of the precast concrete member, exposing reinforcing steel at a few locations in the Arid Dome (Figures 16 and 17). The reinforcing steel appeared to have minimal concrete cover.

Figure 16. Removed spall within the body of the precast element. Note: concrete and reinforcing steel was painted with a blue colored coating.

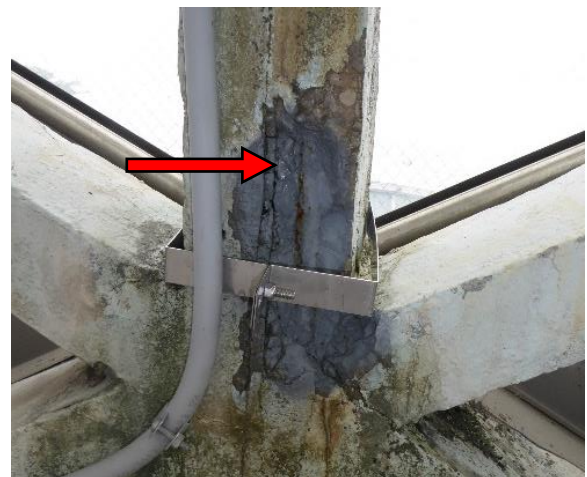
5. Missing grout was observed between precast members at a few locations (Figure 17).
6. Fine, transverse-oriented cracks spaced along the length of the precast members were observed at several locations (Figure 18). Cracks were typically highlighted by soiling and peeling paint.

Figure 17. Removed spall within the body of the precast element. Note missing grout between precast members.

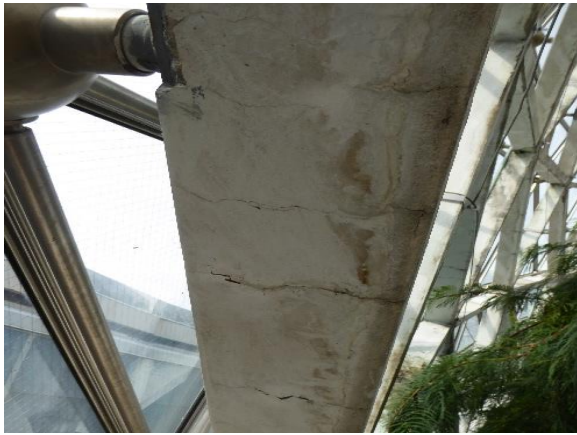
*Figure 18. Transverse cracks on precast member*

The cracks observed on precast members are not an indication of any structural deficiency and appear to be the result of concrete shrinkage and stresses associated with normal structural behavior. In their current state, the cracks will continue to open and close with temperature change. The drying shrinkage in this concrete has mostly taken place and is not a factor to cause further cracking. The cracks should be protected from moisture. GRAEF reported cracks between precast members, and between the concrete base and precast members. We suspect that the cracks were observed in the coating system at the joint between precast members and between the concrete base and precast members. The joint should be sealed during the installation of the new coating system.

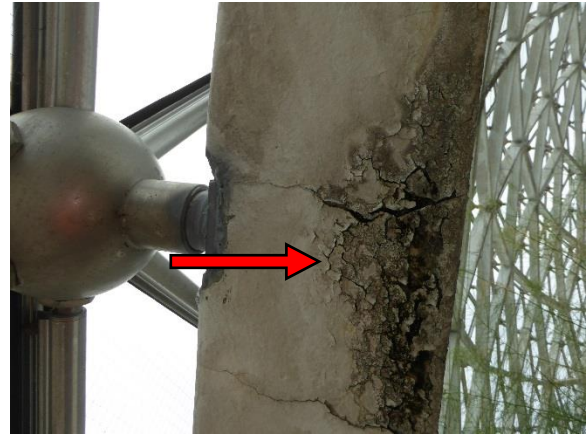
7. Cracked and peeling paint was observed on most precast members (Figure 19).

*Figure 19. View of cracked and peeling coating on precast member*

- We recommend that the following characteristics be considered with the selection of a coating system: concrete carbonation protection, waterproofing, and aesthetics. The recommended coating systems by GRAEF for the precast concrete include an epoxy system and a stain. The stain will not be able to bridge cracks in the concrete and we do not recommend that a stain be installed. We recommend that further research be performed by GRAEF to understand the crack bridging capabilities of the proposed epoxy system. An epoxy system may fade and degrade slowly due to ultraviolet exposure, but could be beneficial to seal the concrete from oxygen depending on future corrosion potential due to the existing concrete carbonation depth and operating environment. A breathable acrylic or acrylic elastomeric coating could also be considered for the precast concrete members. An elastomeric coating will provide good crack bridging capabilities, but may not bond well in a humid or damp environment. A different coating system could be considered for each dome depending on the interior environment. Surface preparation and removal of the existing coating system may prove very difficult due to access and protection. Therefore, we recommend trial installations, bond testing, and evaluation of different coating systems and surface preparation techniques.
