HISTORIC STRUCTURES REPORT

PANAMA HOTEL

HASHIDATE YU BATHHOUSE &
JAPANESE-AMERICAN COLLECTIONS

Published June 18, 2014.

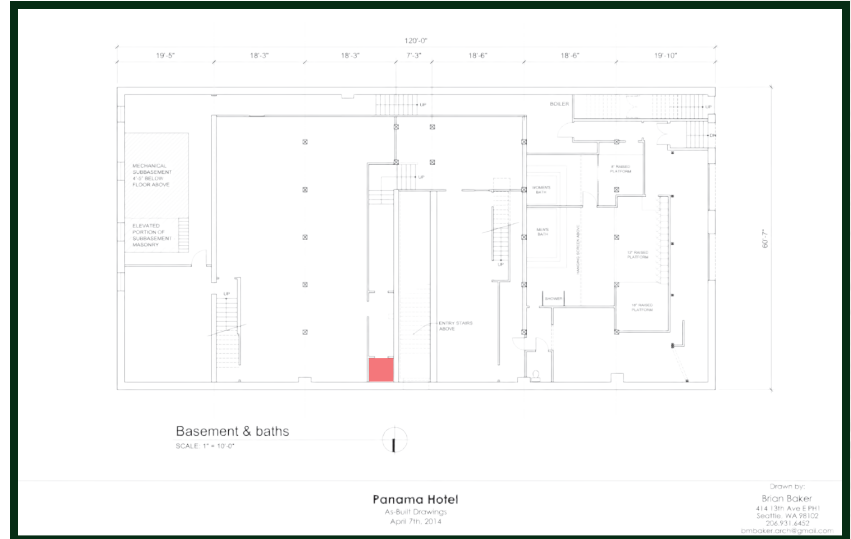
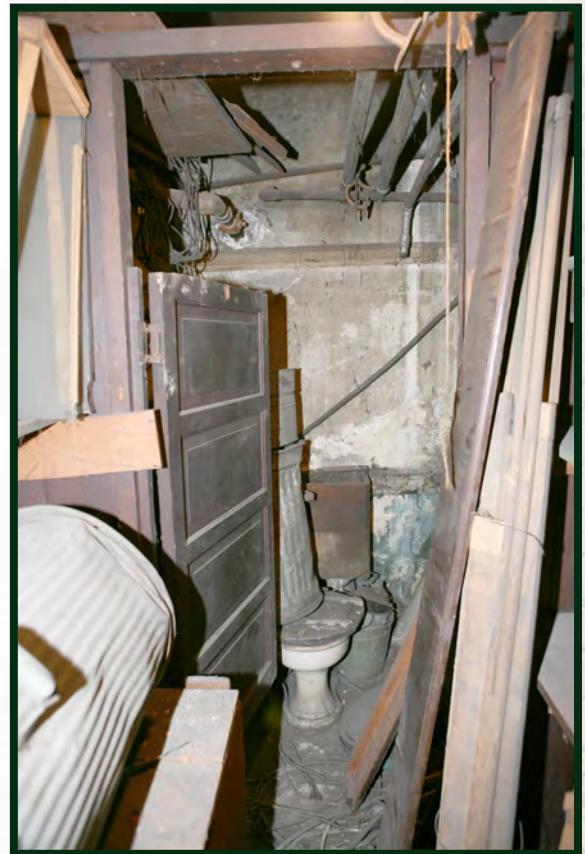
BATHROOM B

Condition

- Overall poor condition
- Extensive plaster and paint damage within the space

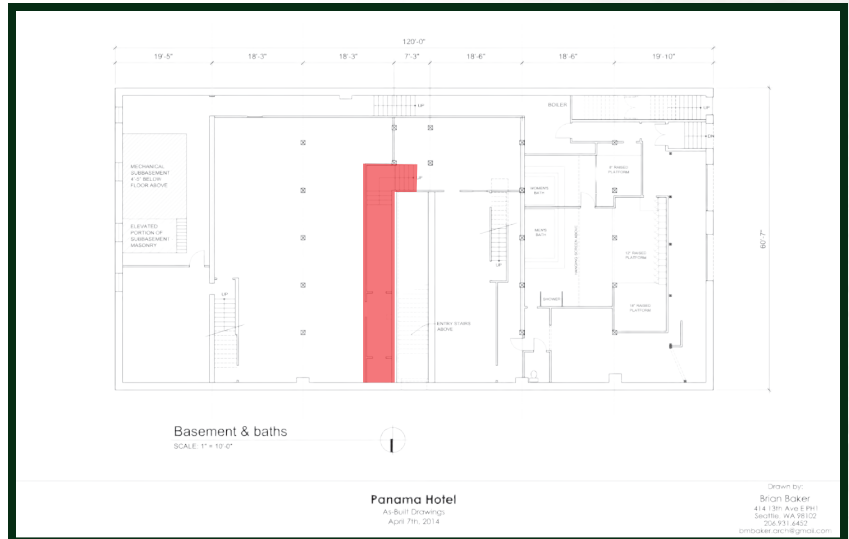
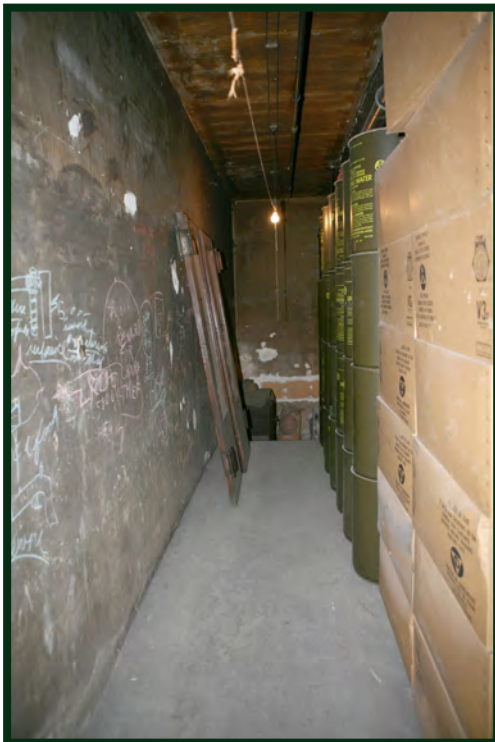
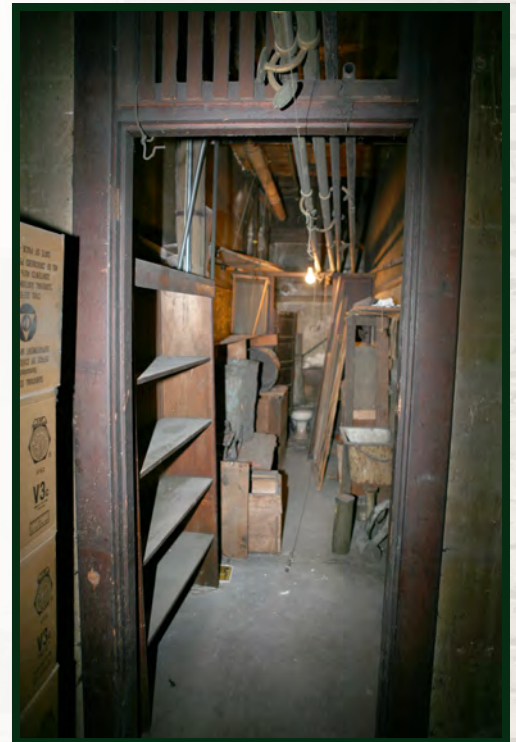
HALLWAY B (SPACE 14)

Condition:

- Overall poor condition
- Extensive soiling along walls, floor and ceiling
- Staining and material deterioration along walls and ceiling from previous water infiltration

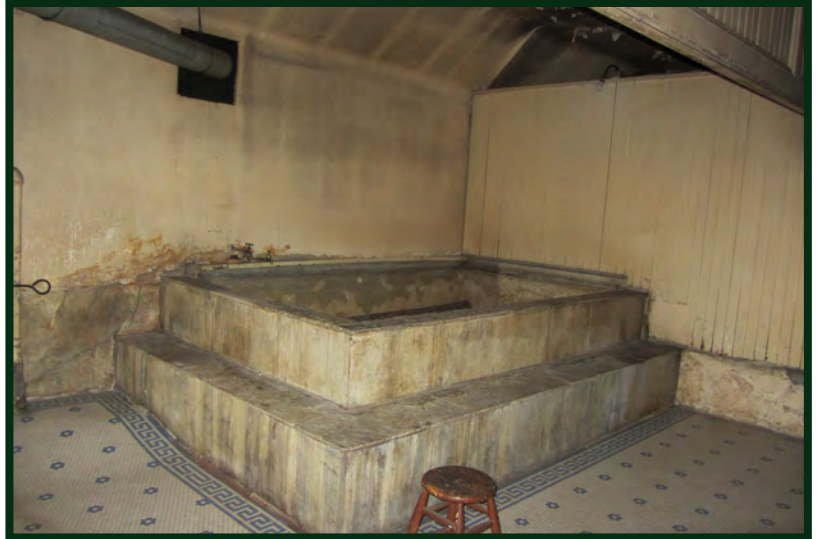
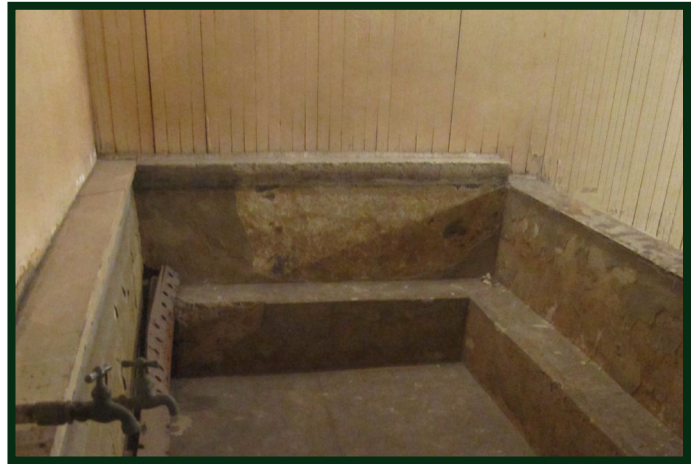
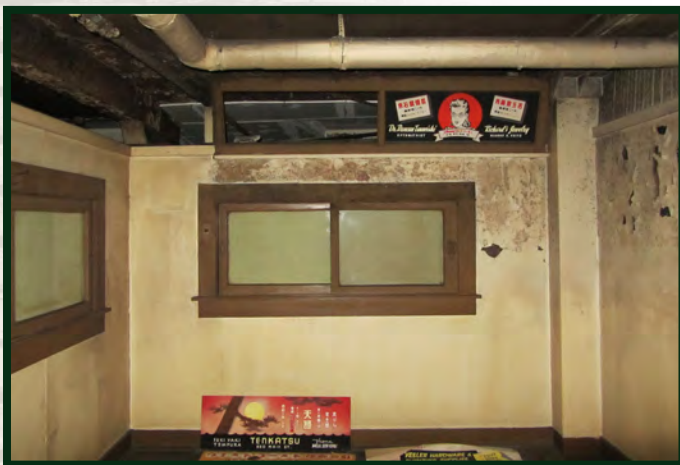
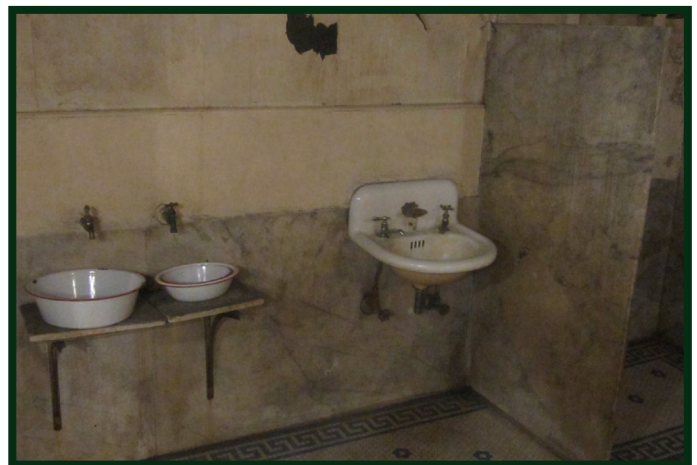
Condition

- Overall fair condition
- Moderate paint deterioration and loss
- General soiling, particularly at upper ceiling and wall surfaces
- Notable pitting and wear along surface of marble at bath, this is part of the character of the bath and should not be changed, much of this pitting is already evident by 1944, as seen in a September 24, 1944 Seattle Times photograph

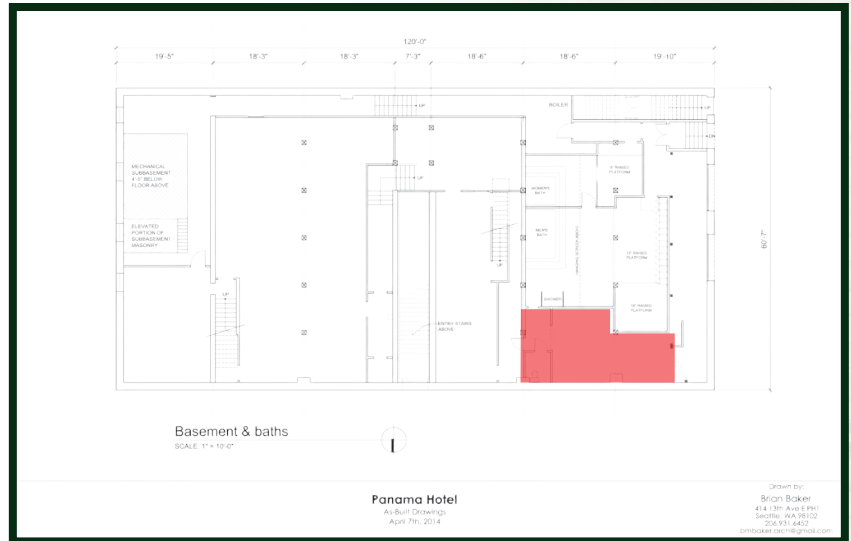
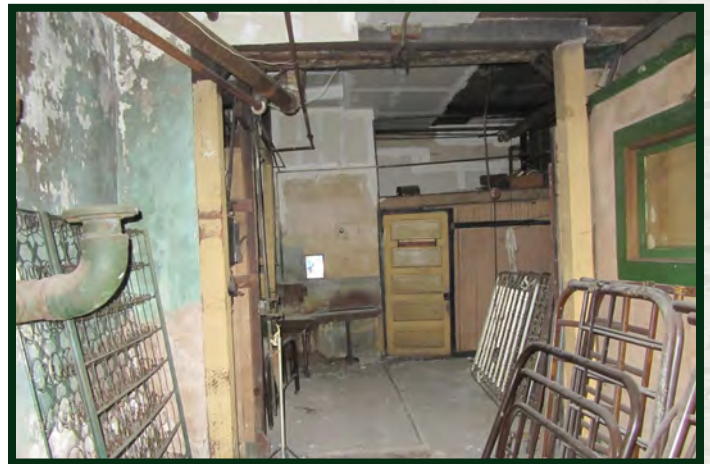
Condition

- Overall poor condition

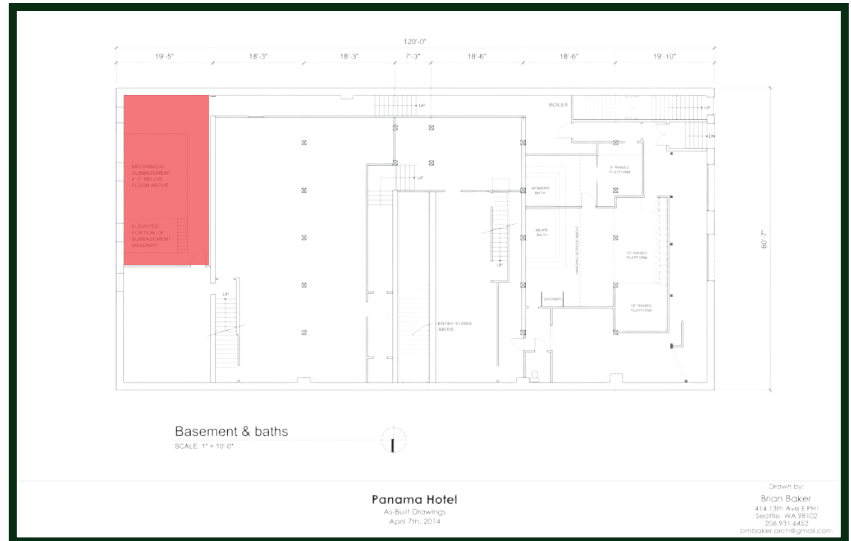
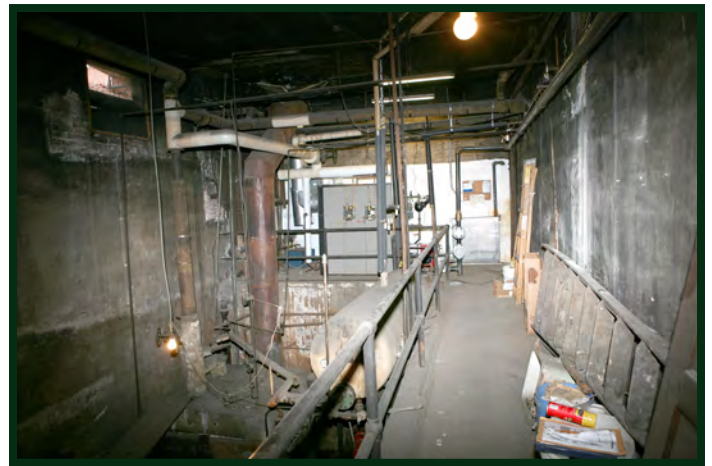
MECHANICAL A (SPACE 2)

Condition

- Overall the space remains in good condition
- The boiler equipment has been upgraded
- Concrete flooring deteriorated below the north corner of the fire door.

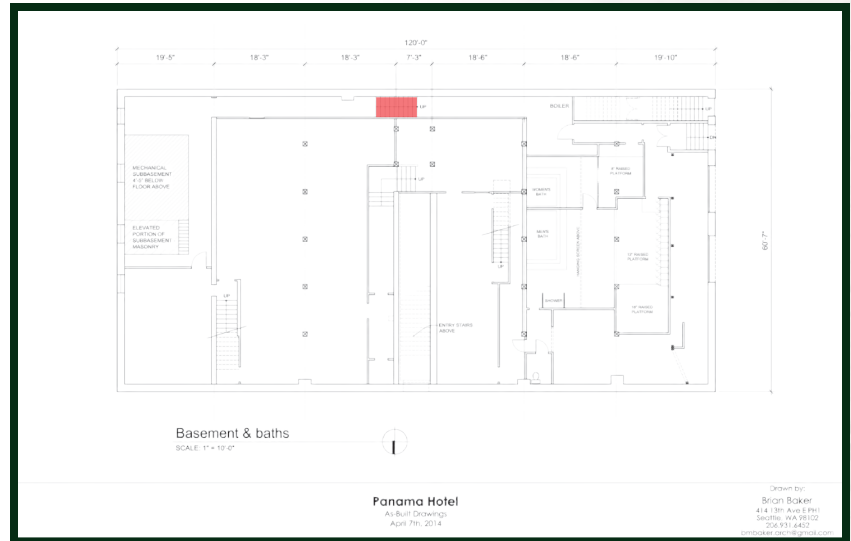
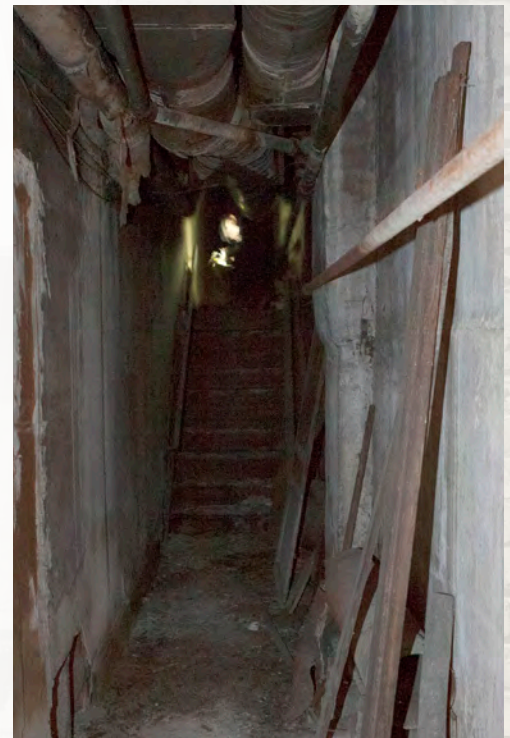
STAIRWELL B

Condition

- Overall in poor condition
- Extensive debris accumulation on the stairs from disuse
- Water damage evident on some risers and tread from previous leaks

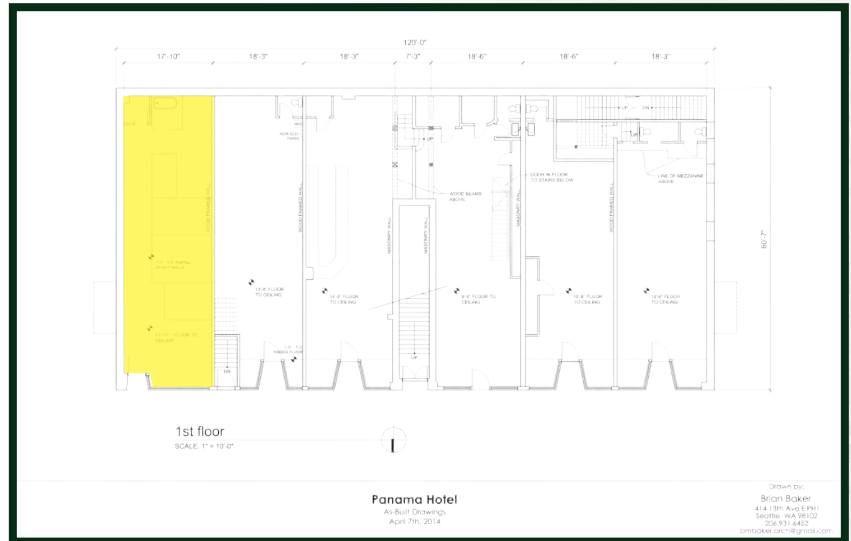
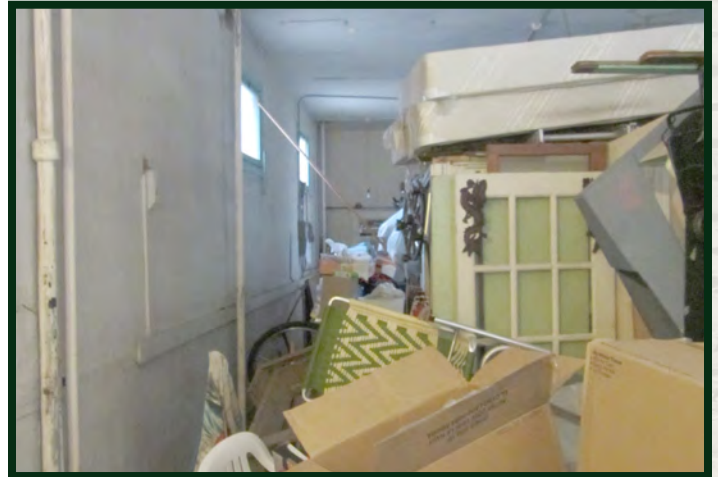
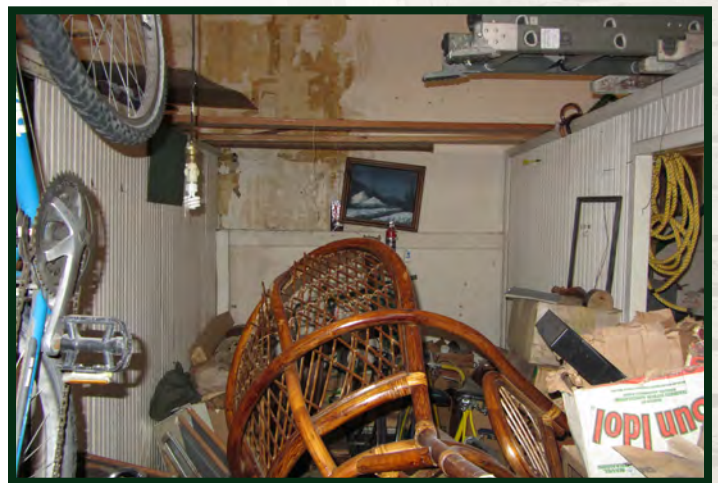
Condition:

- Overall fair condition
- Water damage evident along the ceiling from overflowing sinks in the hotel rooms above
- Extensive stored items within the space that appear to be contemporary items

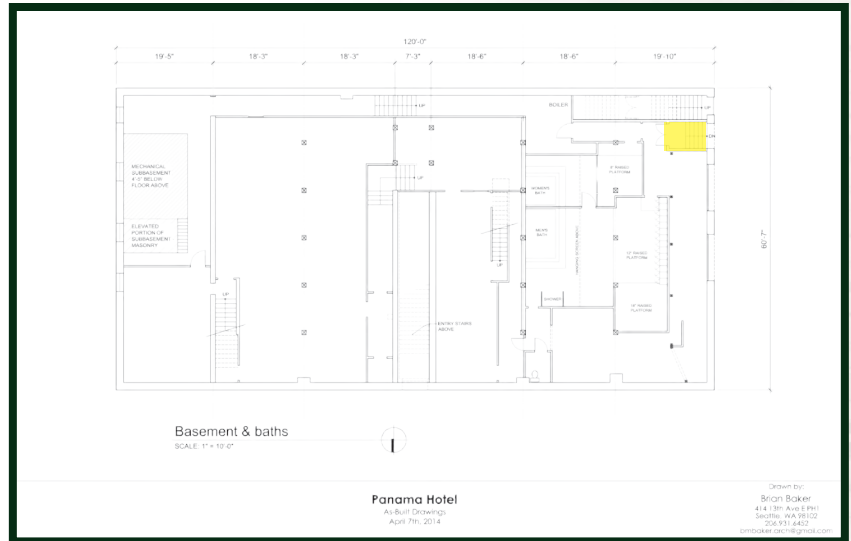
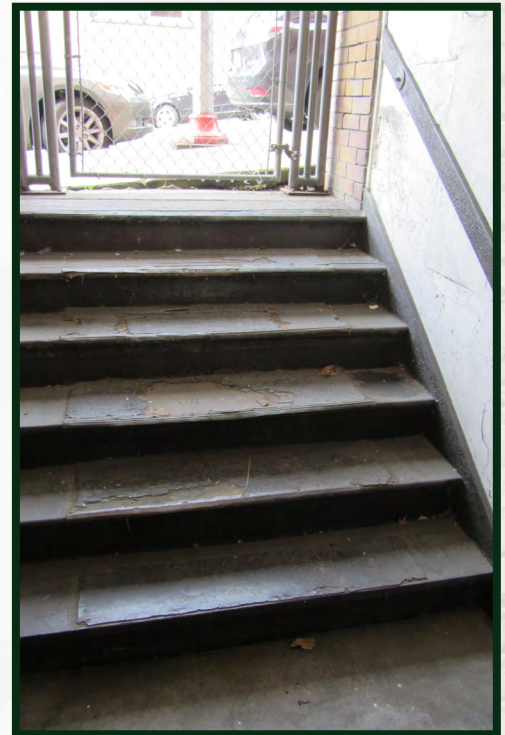
ENTRANCE AND STAIRWELL, 302 SIXTH AVENUE SOUTH

Condition:

- Weathered wood
- Missing hardware
- Railings and metal finishes have been stolen
- Flat metal arch (lintel) shows deterioration, likely from steam escaping the bathhouse
- Pitted, repainted
- Composite lintel, 1 section under brick veneer, other section under unreinforced masonry structure
- Well-worn and deteriorated stairs; treads soft
- Weathered threshold

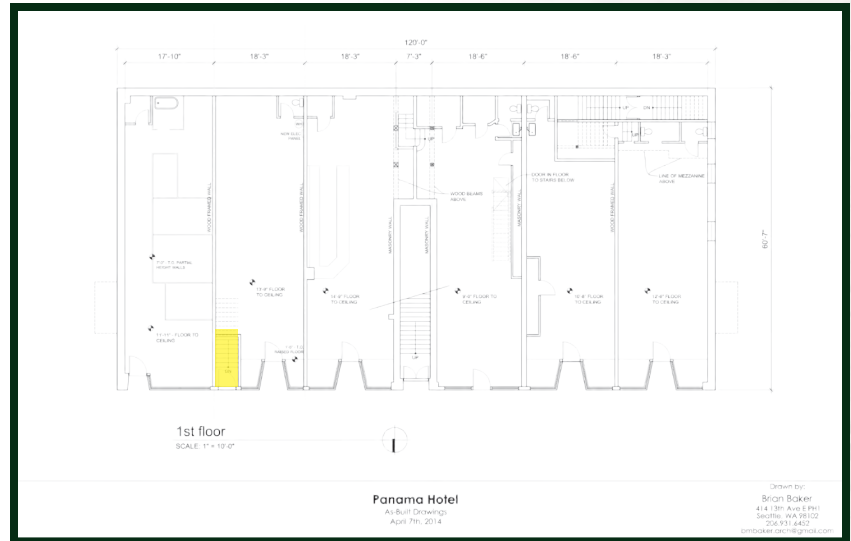
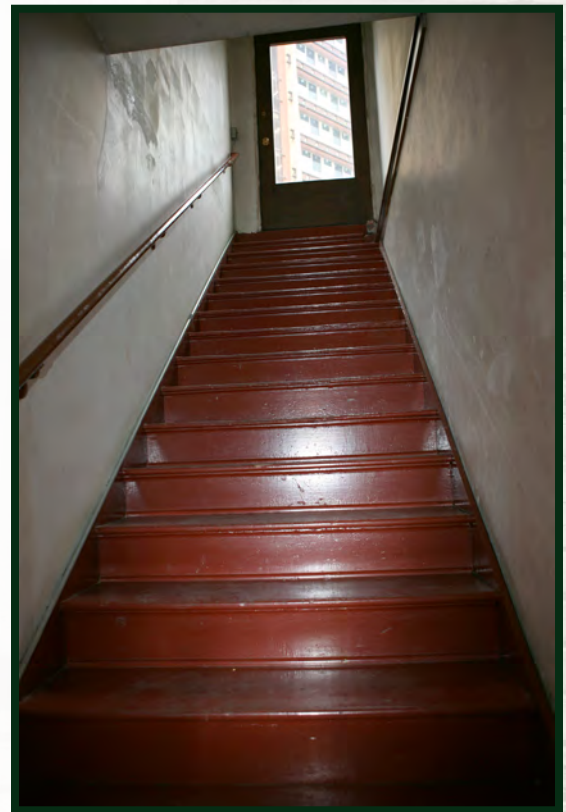
ENTRANCE AND STAIRWELL, 609 1/2 SOUTH MAIN STREET

Condition:

- Overall fair condition

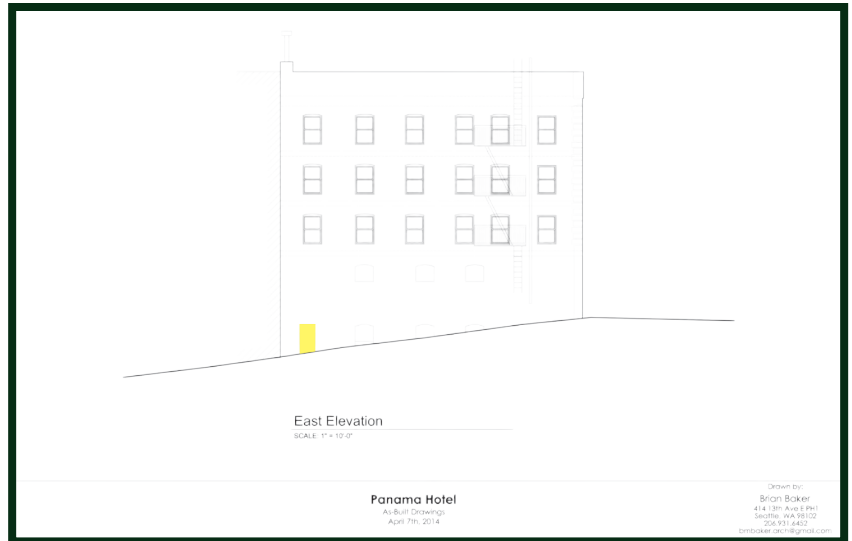
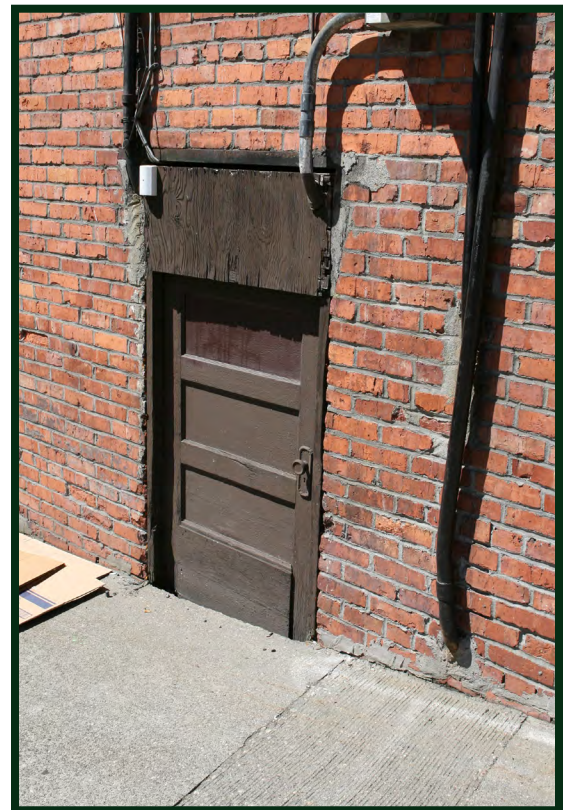
ENTRANCE, EAST FACADE

Condition:

- Weathered wood door and frame
- Original hardware rusted

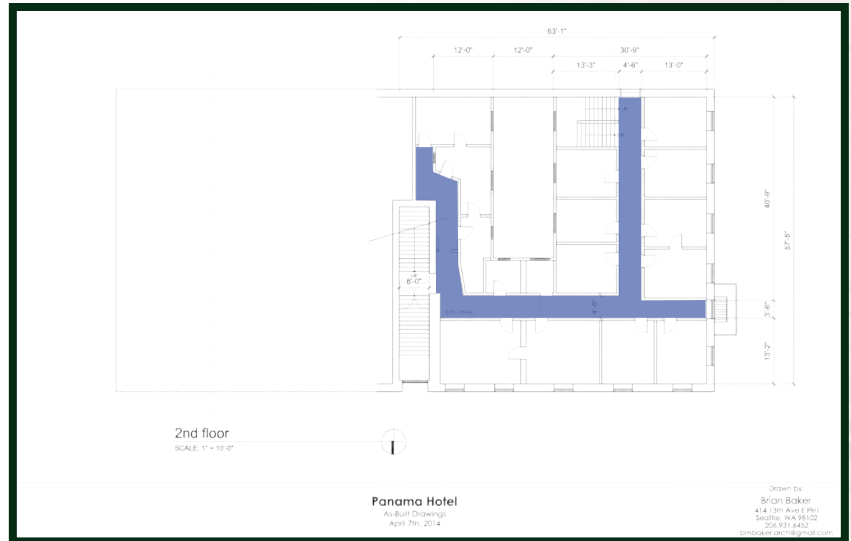
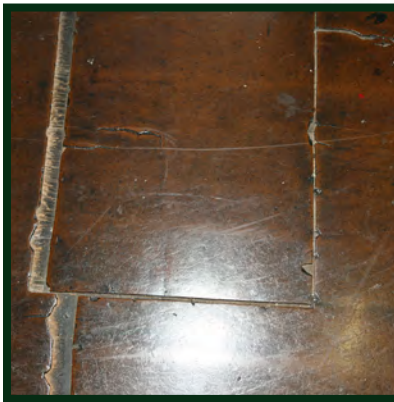
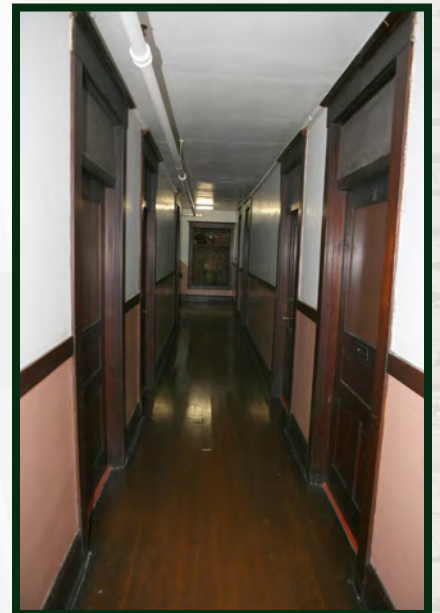
CORRIDOR

Condition

- Overall good condition
- Leather flooring deterioration
- Plaster wall condition
- Wood trim

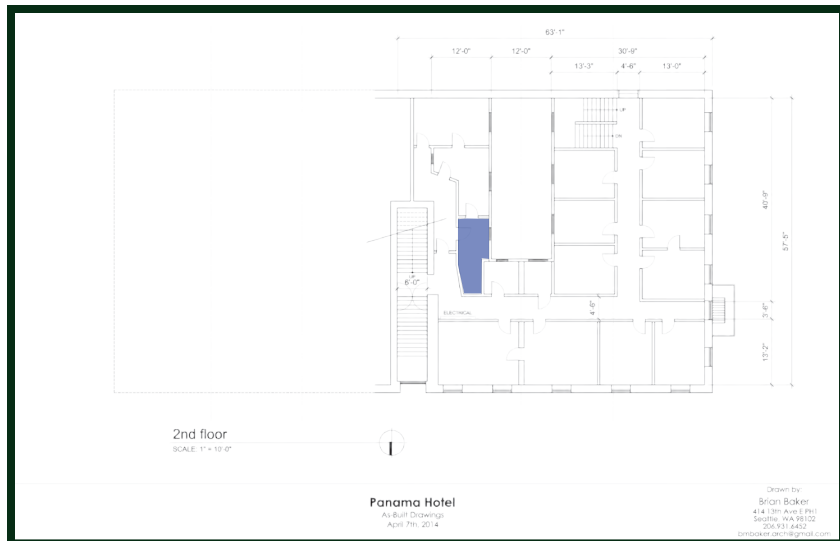
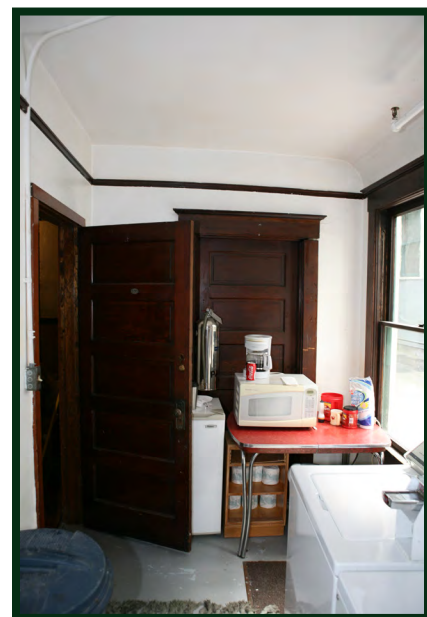
LAUNDRY

Condition

- Overall good condition

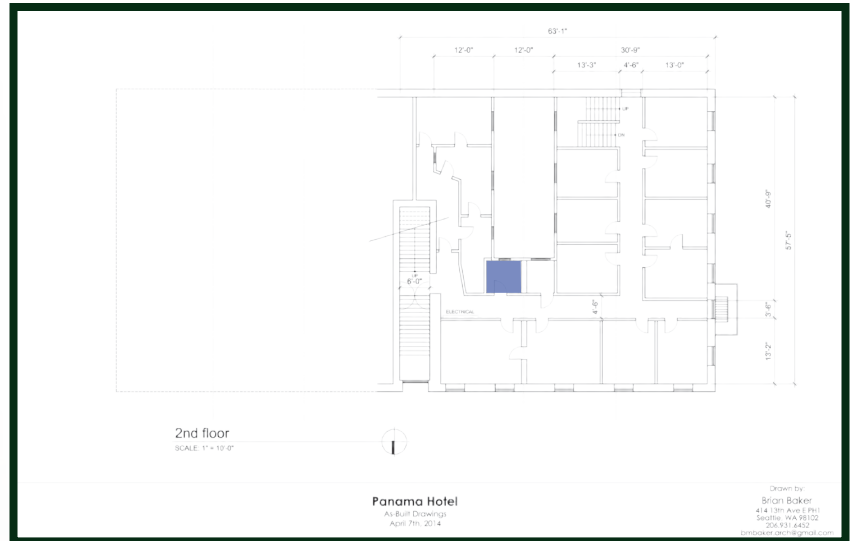
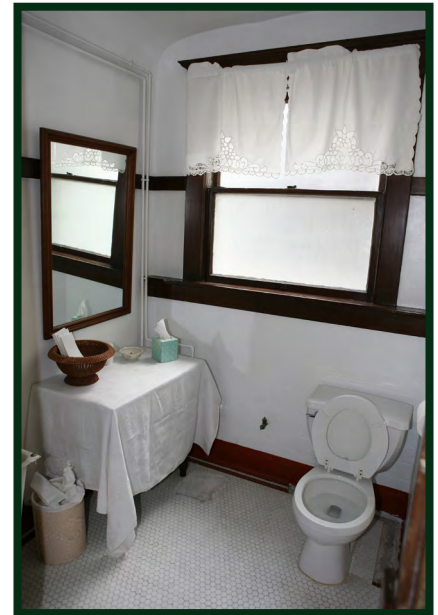
- Overall fair condition
- Several broken tiles and missing tiles behind toilet, new tiles at toilet on west side
- Former sink location patched along south wall

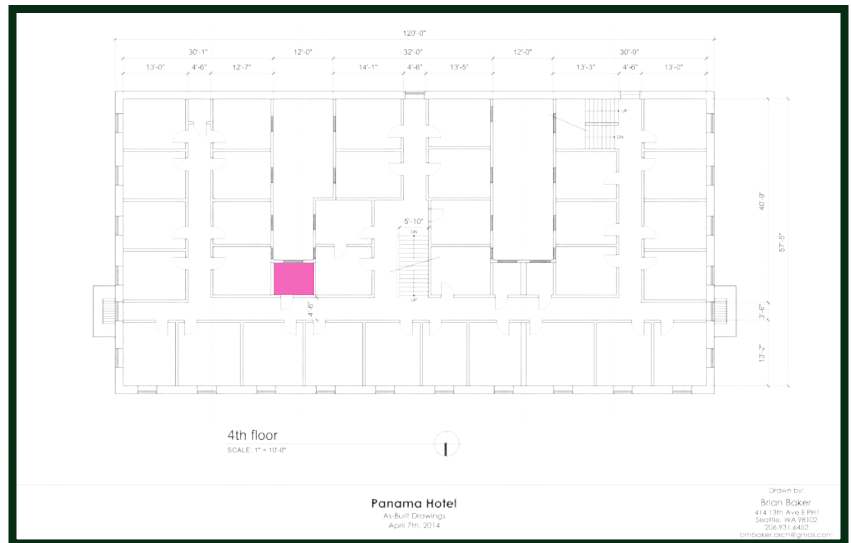
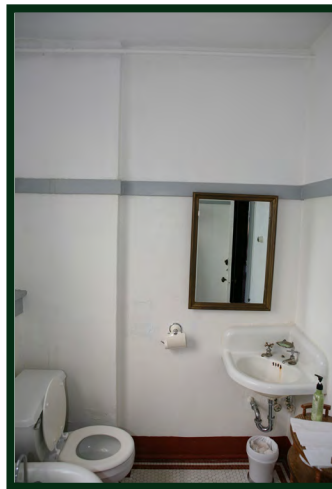
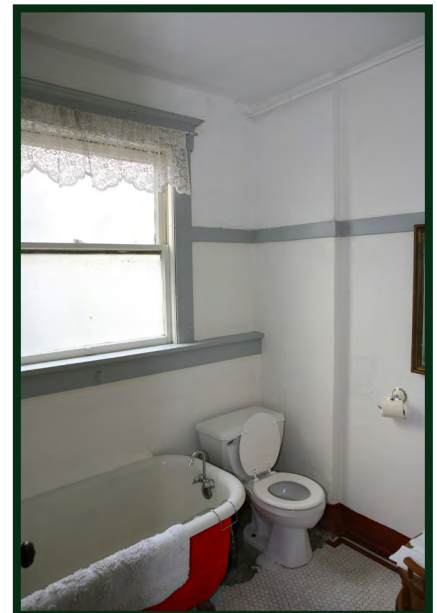
BATHROOM 429

- **Moderate integrity**
- Painting of all wood work
- Missing tile around new toilet
- Damaged plaster around new toilet

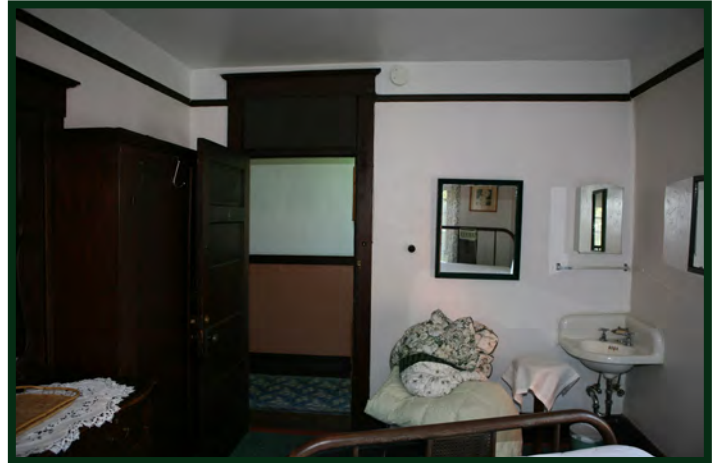
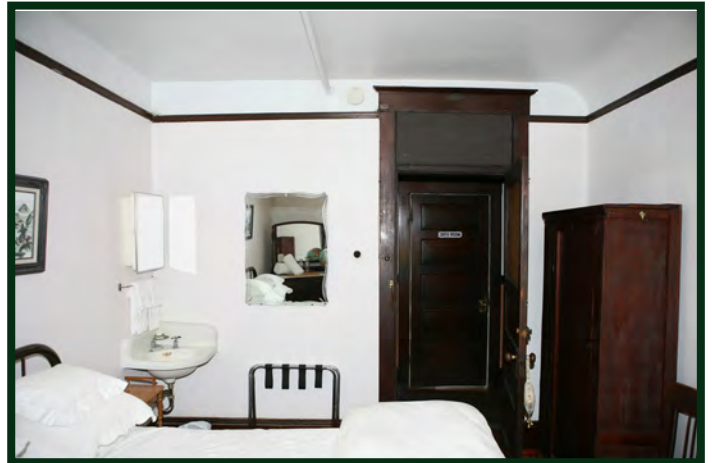
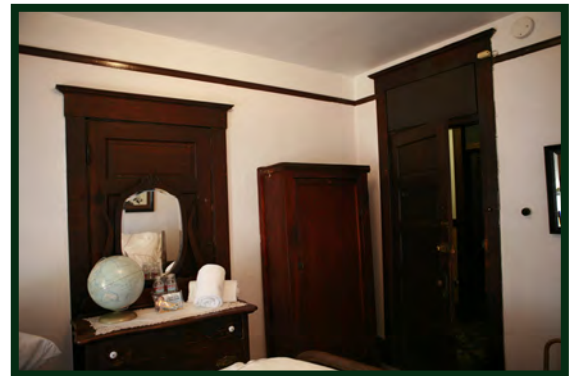
- Moderate integrity
- Split casing at corridor and at strike plate at door
- Picture rail offset at northeast corner
- Cracking in plaster along south wall and east side
- Split panel in corridor door, multiple previous fasteners and holes
- Door knobs loose

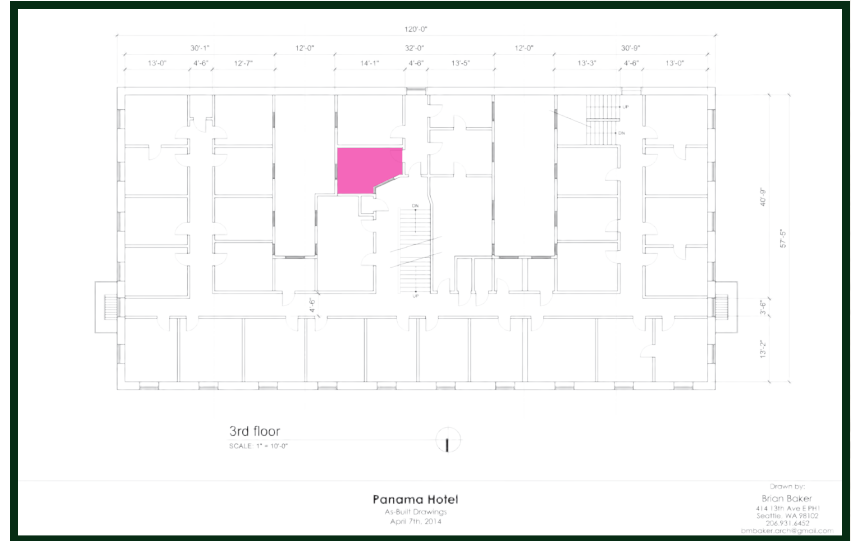
OFFICE

- Overall good condition
- Plaster cracking at ceiling and walls

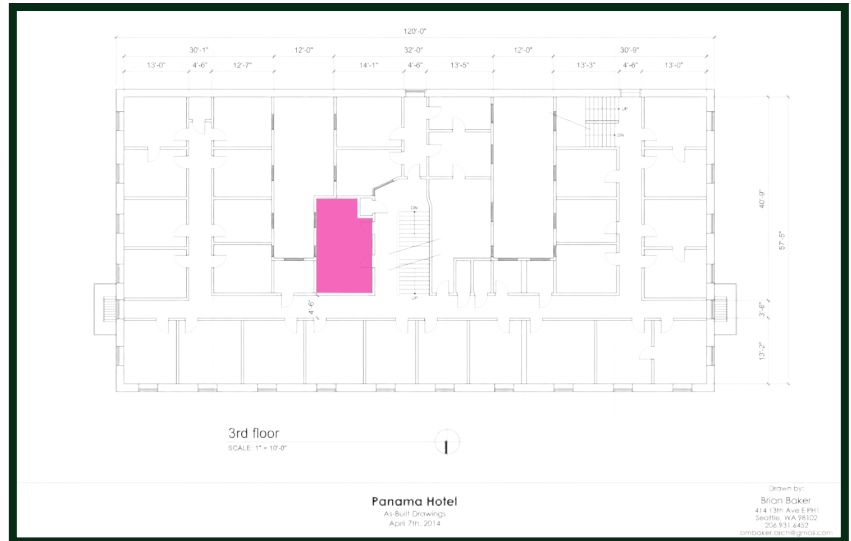
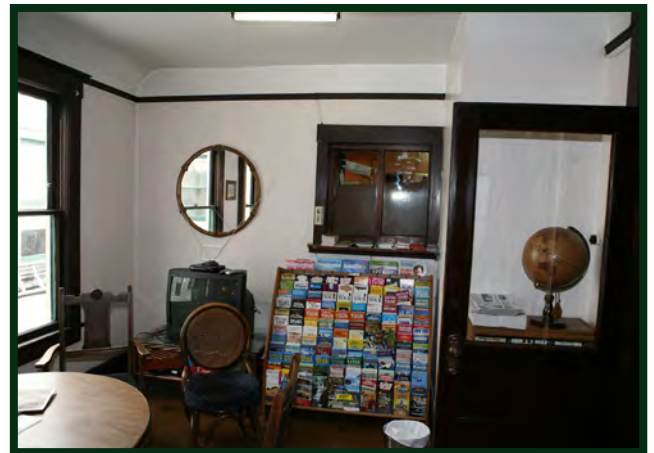
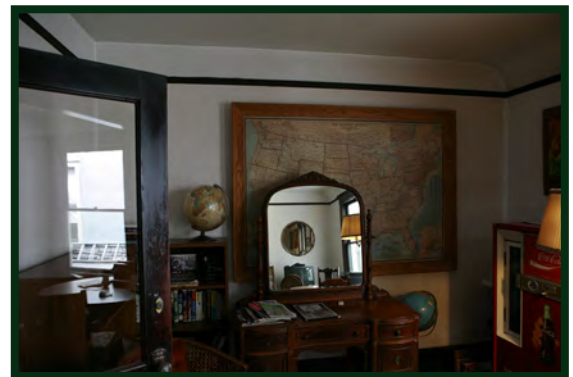
RECEPTION ROOM

- Overall good condition
- Wear and divots in leather floor at furniture locations
- Plaster cracking at ceiling and walls

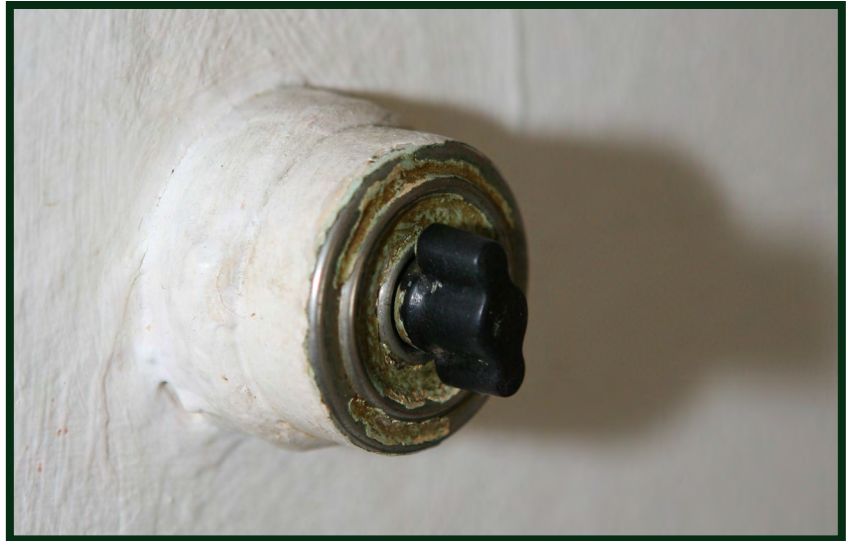
ELECTRICAL SYSTEM

- Overall in poor condition
- Replacement parts are becoming increasingly difficult to obtain

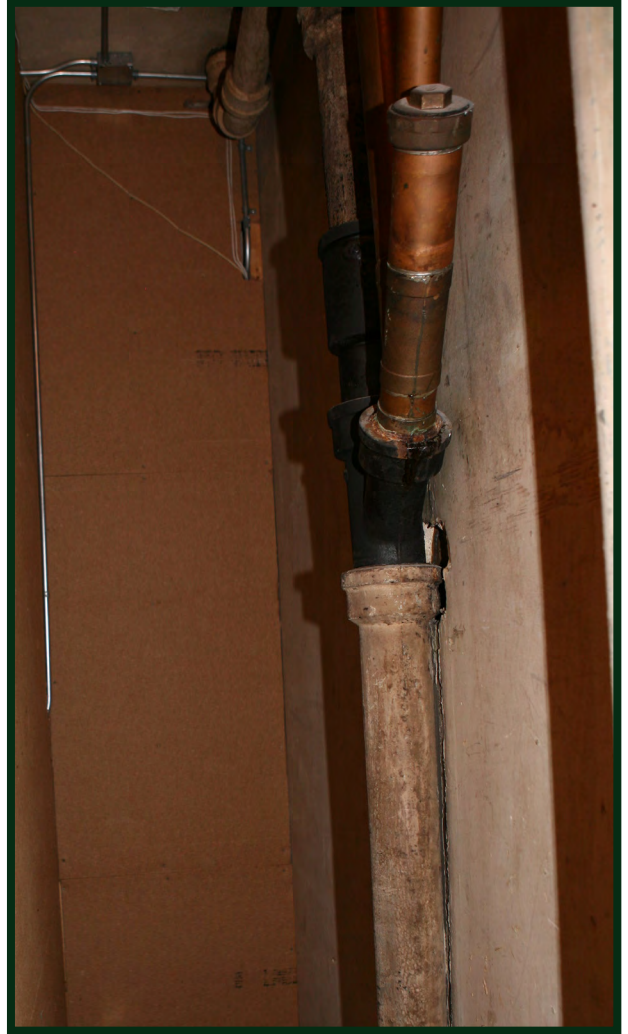
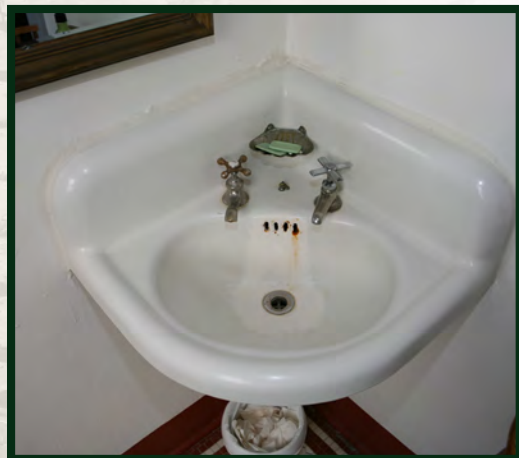
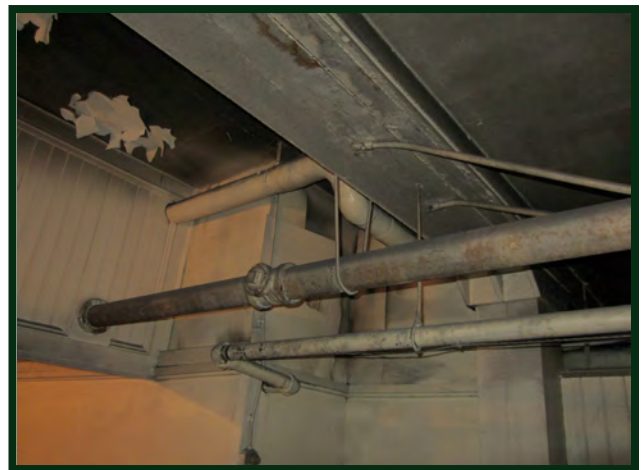
Condition

- Overall poor condition with potential asbestos wrap on some of the basement steam lines. No abatement has been done on the pipe insulation.
- The original fixtures that remain are the key elements for retention for interpretation
- The lines feeding these fixtures and new fixtures are in need of upgrades, particularly to the hotel spaces

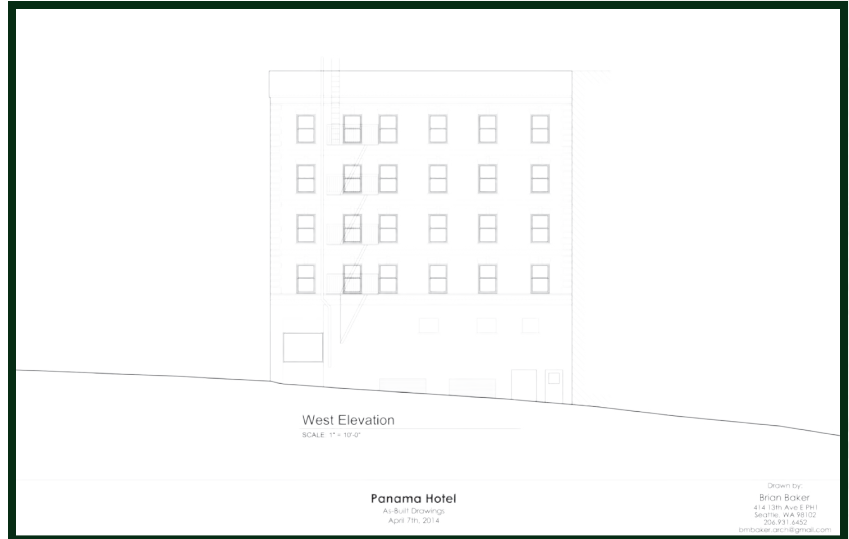
Condition

- Overall fair condition
- Refer to the condition statements for the above character-defining features for detailed information
- Some windows are inoperable
- Caulking between upper brick mold and lintels painted over
- Significant weathering on bottom rails

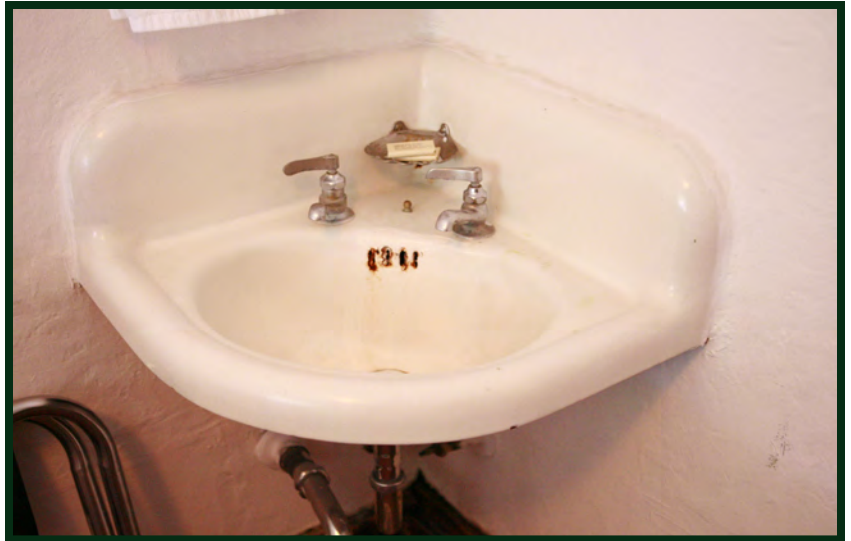
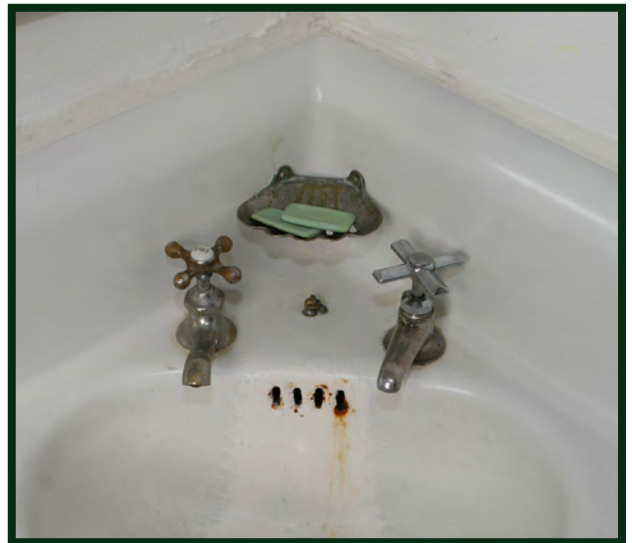
BASIN, CORNER

Condition

- Overall fair condition.
- Missing stopper at some sinks
- Several taps replaced, compatible types
- Plumbing below sink in poor condition in some locations

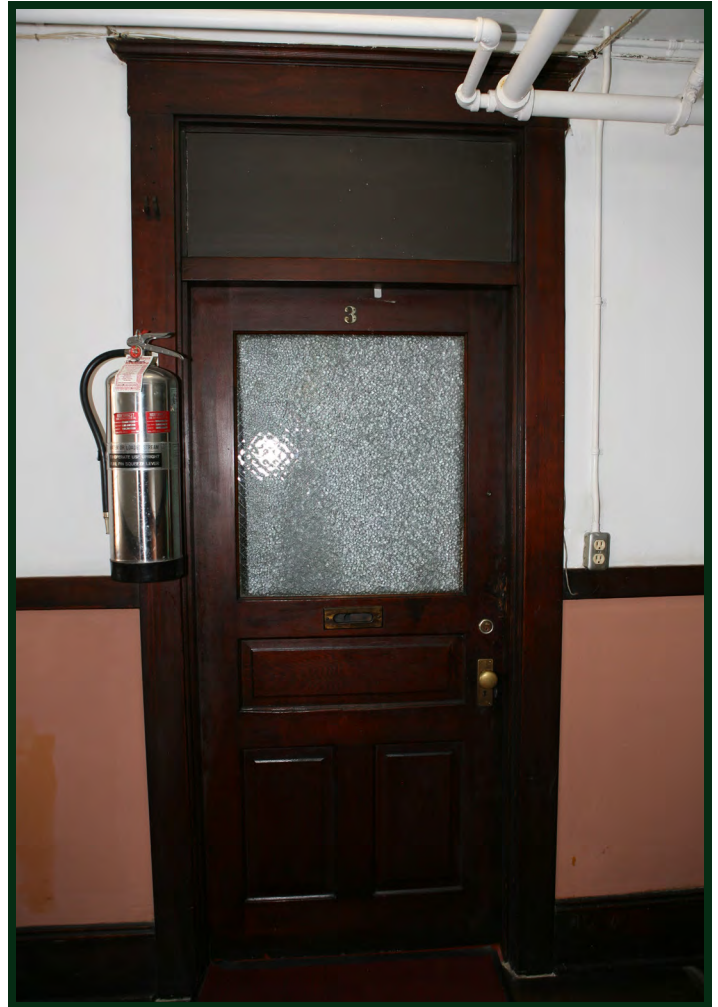
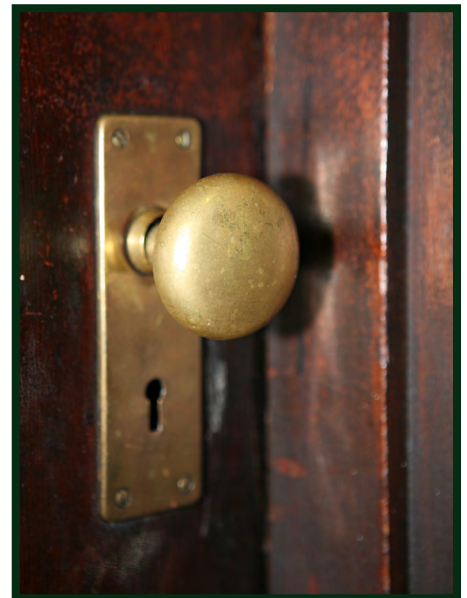
DOOR, TYPE A

Condition:

- Overall good condition
- Plumbing projects through some transoms
- Layers of paint on threshold
- Some damaged thresholds
- Nail and screw holes in some doors and jambs
- Damaged or missing molding pieces within door jamb

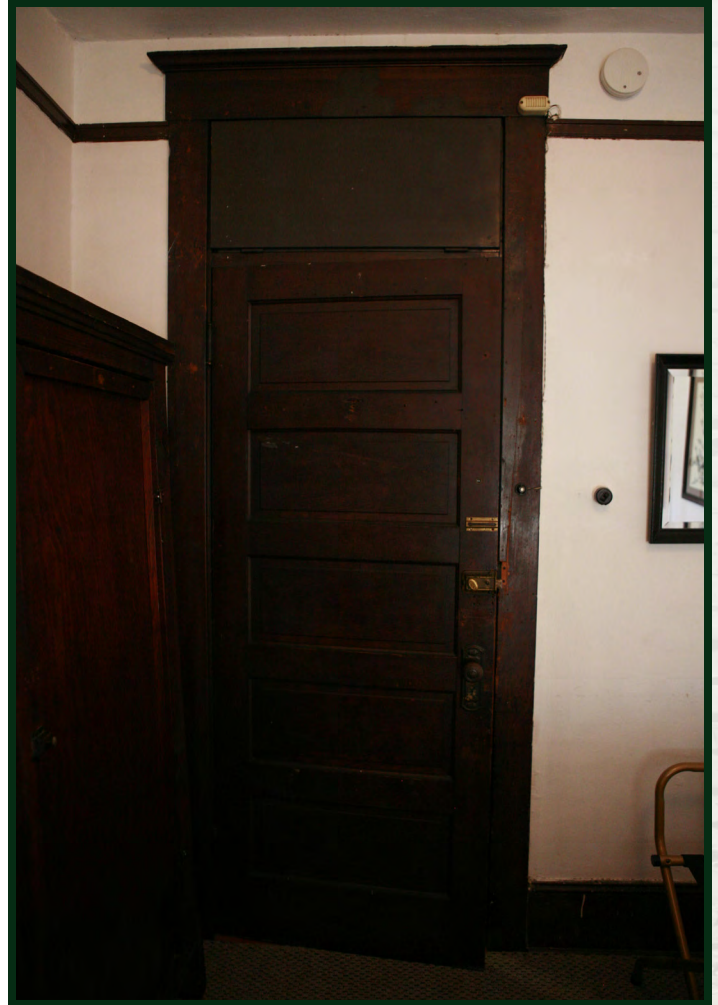
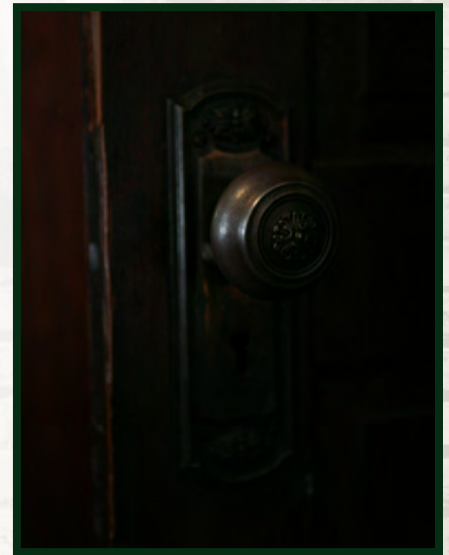
DOOR, TYPE B

Condition

- Overall good condition
- Loose door knobs at some locations
- Most doors have been refinished
- Filled holes in jambs
- Nail and screw holes jambs
- Added eye screw in one door jamb (Door 10)
- Damaged or missing molding pieces within door jamb

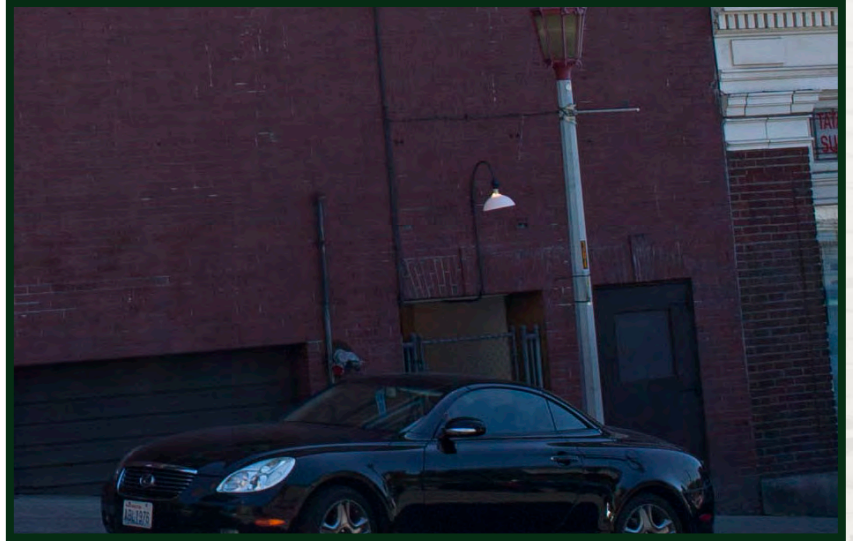
DOOR, TYPE G

Condition

- Overall fair condition
- Extensive finish loss on door stile near push plate

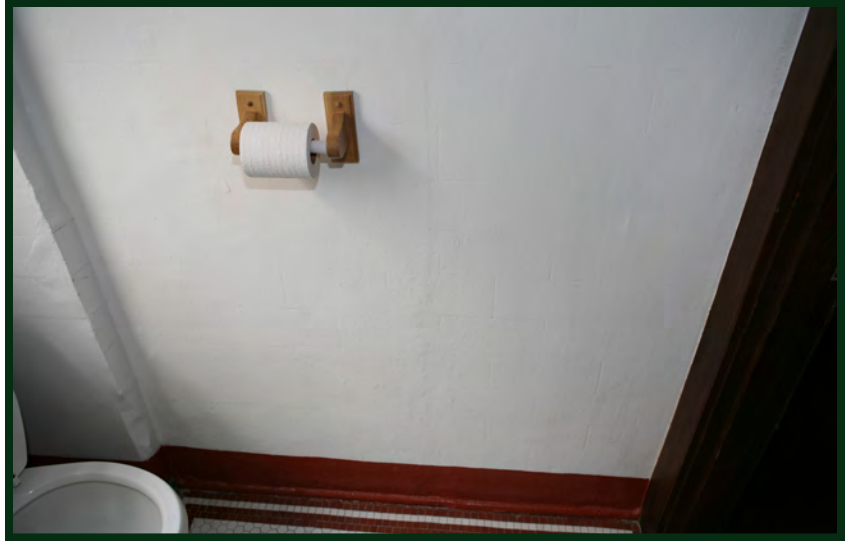
PLASTER, WALLS

Condition

- Overall fair condition
- Some wear at outer corners from impacts

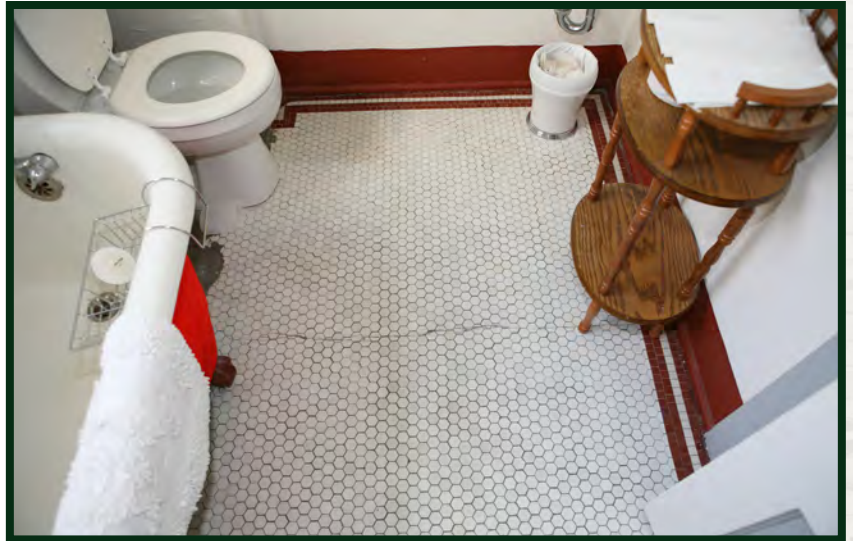
- Overall fair condition

- Sections removed around toilets
