HISTORIC STRUCTURES REPORT

PANAMA HOTEL

HASHIDATE YU BATHHOUSE &
JAPANESE-AMERICAN COLLECTIONS

Published June 18, 2014.

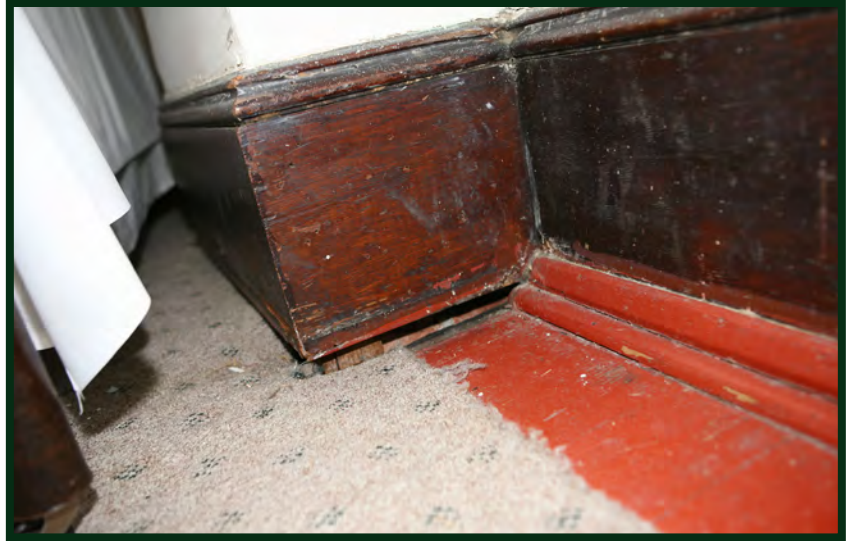
TRIM, BASEBOARD

- Overall good condition
- Some outer corners opening
- Significant water damage and material loss at the second floor corridor, at west end outer corner

- Previously refinished
- Some phone lines stapled to cap and holes through base for room access
- Base shoe pulled and replaced or reinstalled as part of leather flooring installation
- Over paint on base board in areas from wall painting

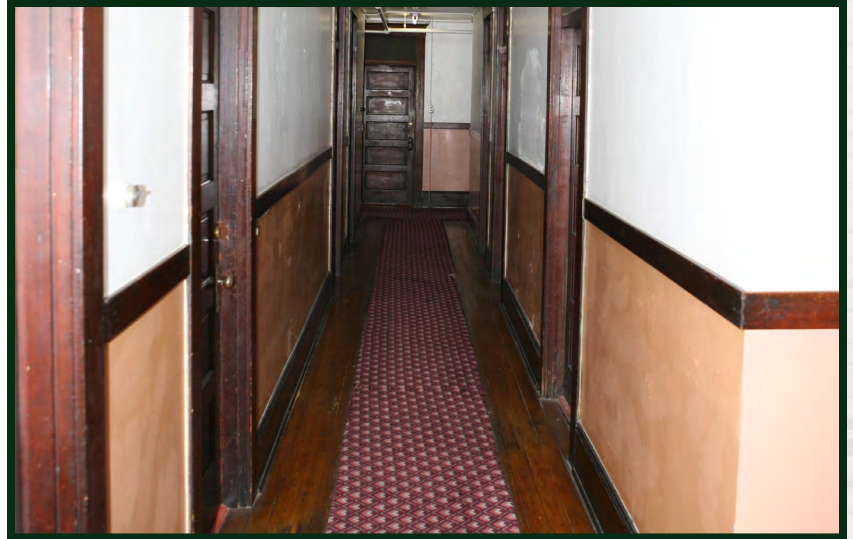
TRIM, CHAIR RAIL

- Overall good condition

- Previously refinished
- Some data lines stapled along top of rail into wall

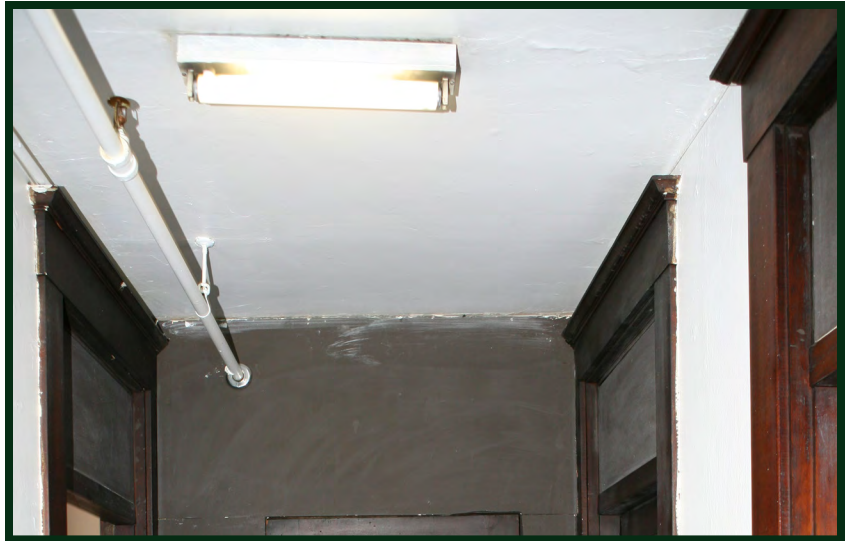
TRIM, DOORWAYS

- Some pitted surrounds
- Some damaged surround—added nails, nail holes, chips at type C doors
- Added eye hooks screwed into surround at type C doors

- Some refinished sections
- Some new surrounds installed at type B door locations (2 1/2-inch casing, 4 1/2-inch header)

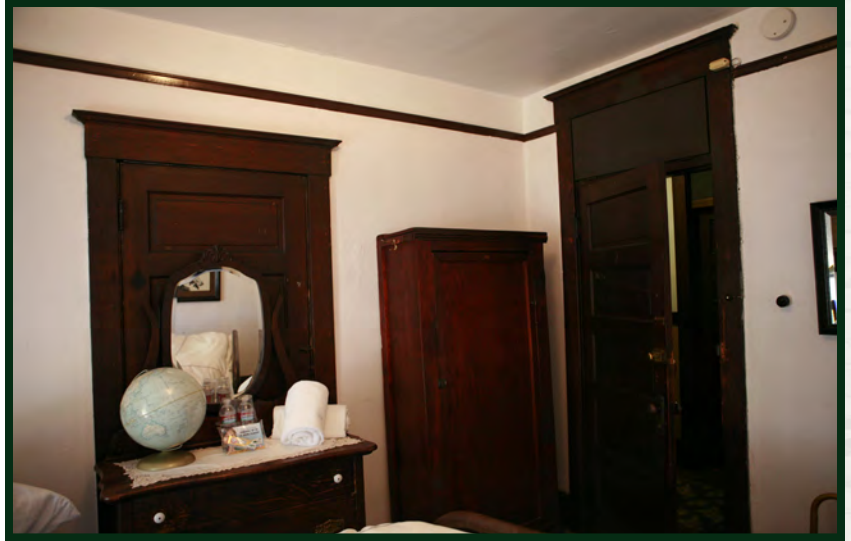
TRIM, PICTURE MOLDING

- Overall good condition

- Added paint layers

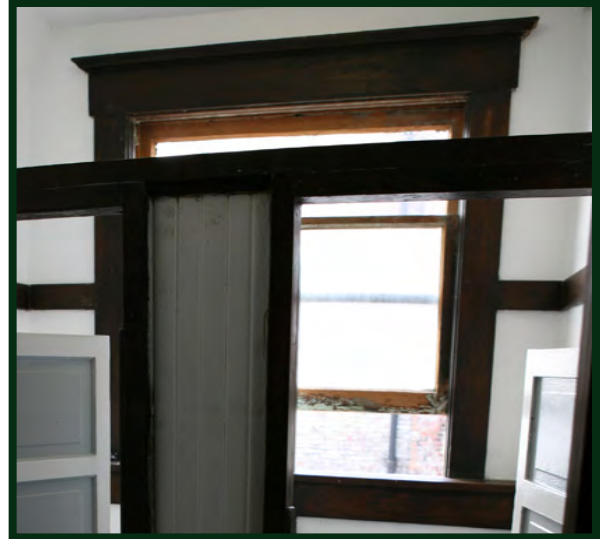
TRIM, WINDOWS

- Overall in fair condition
- Nail and screw holes in surround and frieze
- Moldings, separating from wall (south end walls)
- Holes in casings
- Attached curtain rod(s) to casings

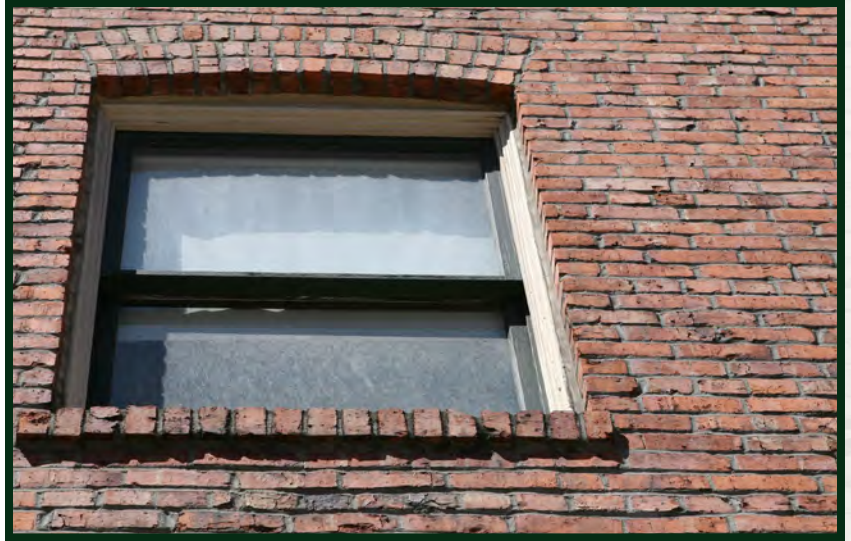
WINDOW, TYPE A

- Overall in poor condition
- Nail and screw holes in surround and frieze
- Moldings, separating from wall (south end walls)
- Holes in casings

- Scraped window jambs, finish removed
- Attached curtain rod(s) to casings
- Damaged inner stops
- Damaged parting beads
- Upper sash nailed partially open on several windows
- Upper sash hung but not operable from interior on several windows
- Damaged brick mold
- Caulking at upper brick mold and lintel

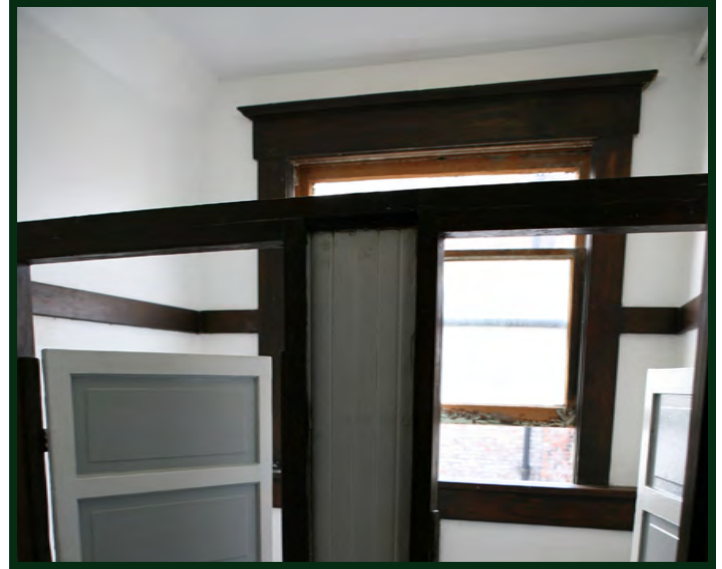
- Overall in poor condition
- Several have been refinished, and at least one is in the process of being stripped of previous paint layers and refinished
- Painted and deteriorated paint at inner jamb and upper soffit jamb
- Damaged parting beads
- Painted sash cords
- Cut sash cords
- Damaged brick mold
- Caulking at upper brick mold and lintel

- Added weather stripping at stiles of lower sash
- Non-historic curtain attached to casing headers
- Non-historic roller blinds added
- New privacy glass added
- Added privacy film over glazing

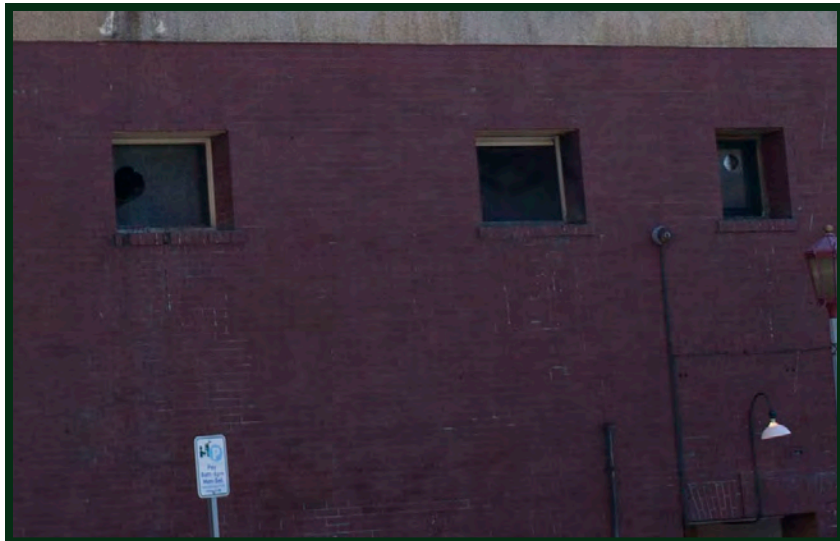
WINDOW, TYPE D

- Overall in poor condition
- Damaged brick mold

- Kitchen vent extended out the northernmost of the west facade windows
