# MITCHELL PARK HORTICULTURAL CONSERVATORY DOMES Peer Review

## **Final Report**

March 14, 2017

WJE No. 2016.2700

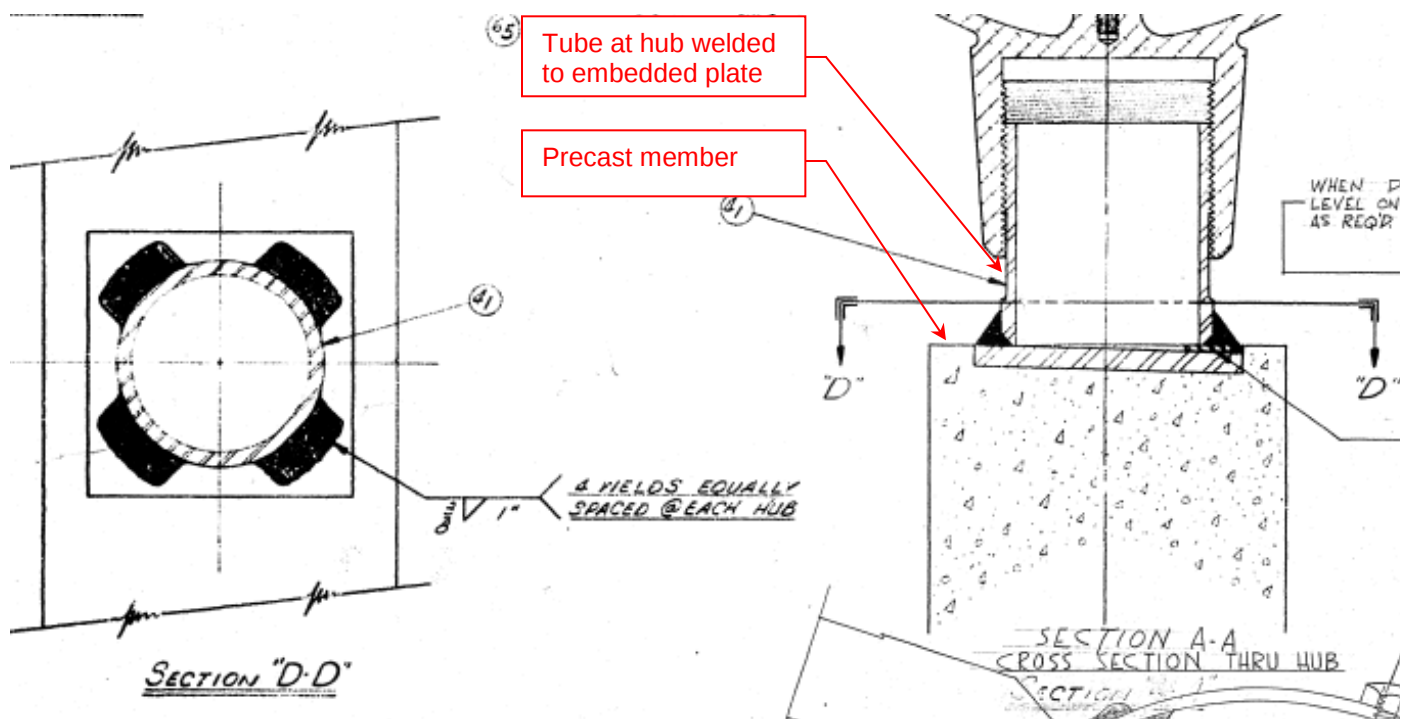
12. The circular hub is welded to an embedded plate in the precast concrete members (Figure 8). The embedded plate in the precast members is flush with the surface of the concrete.

Figure 8. Section through hub from original drawings showing hub welded to embedded plate in precast concrete member

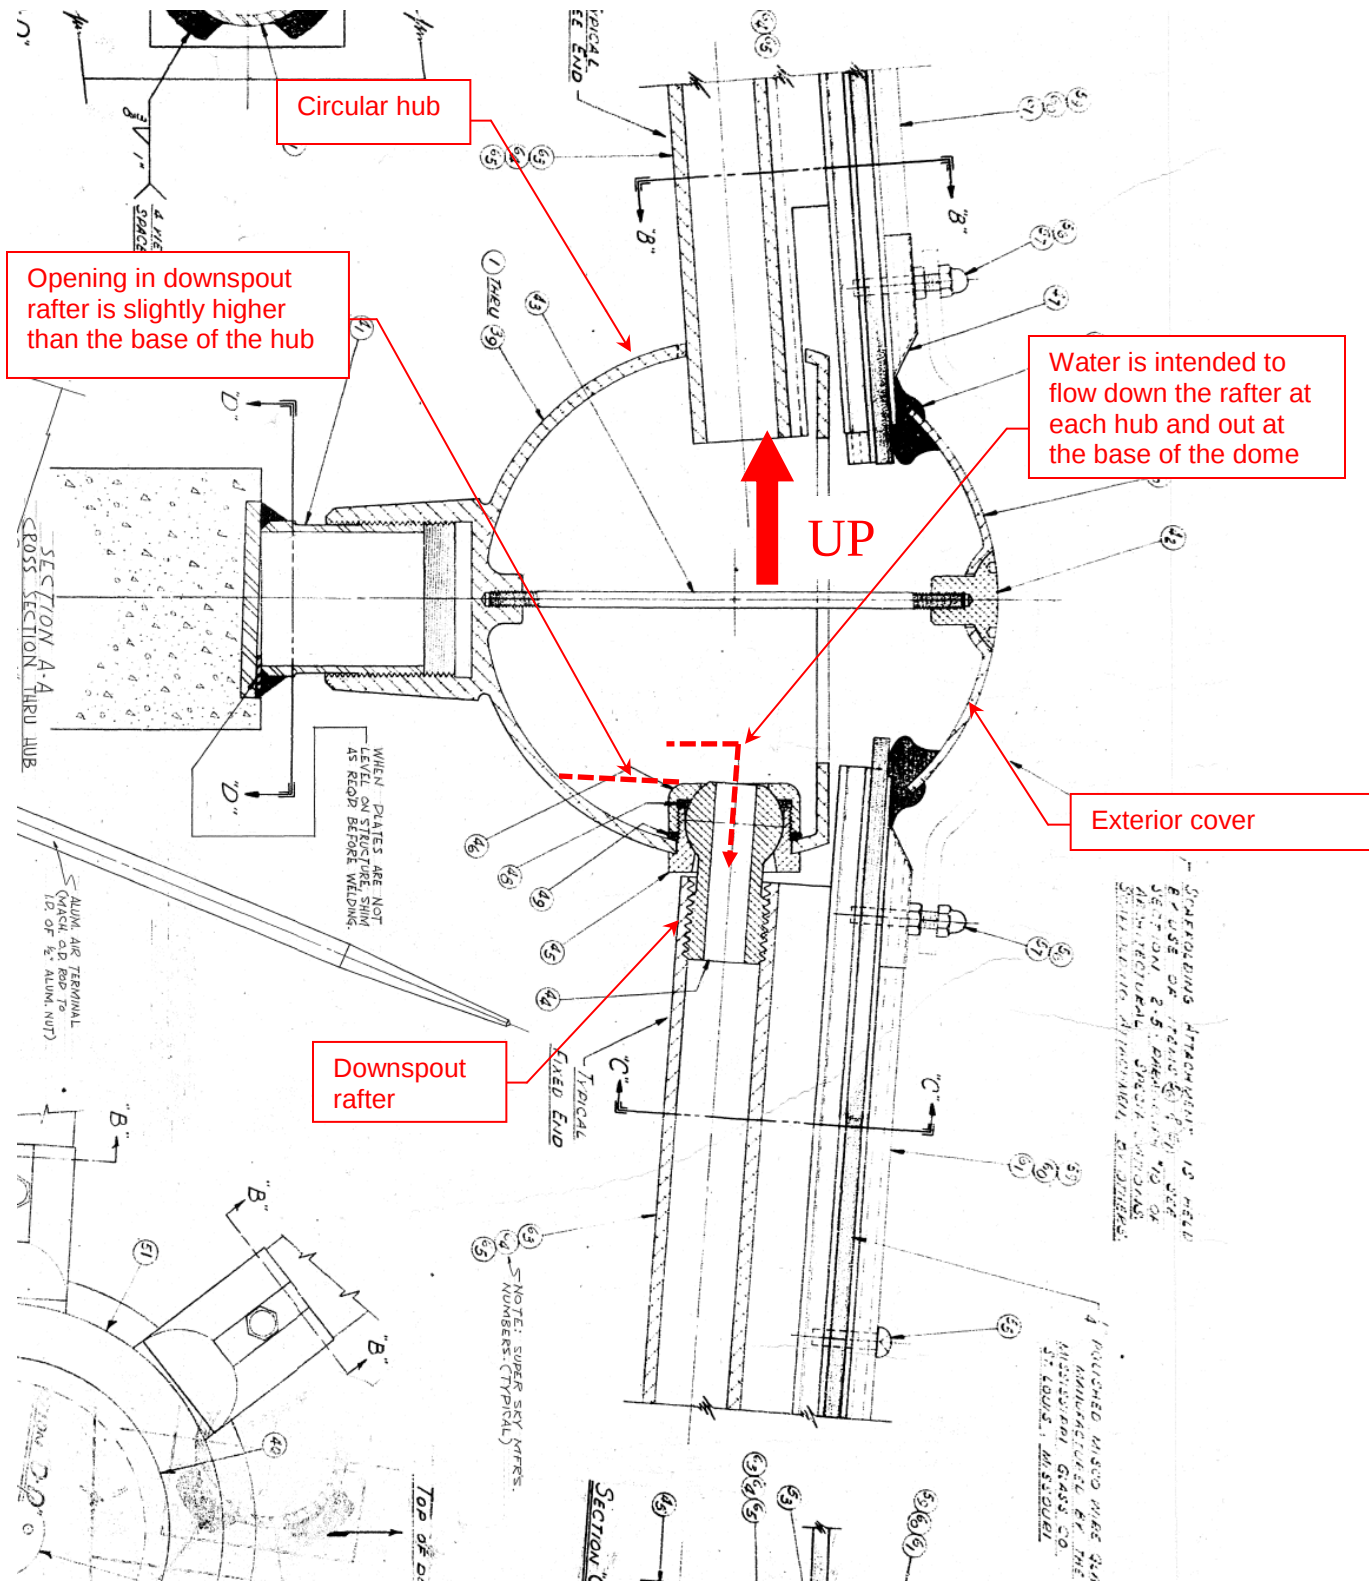
13. Aluminum rafters which are part of the cladding drainage system frame into the circular hubs (Figure 9). The hubs have an exterior cover that was originally set in a mastic or sealant. Water is intended to flow down the rafters at each hub. The opening in the downspout rafter (the rafter that extends downward from the hub to the adjacent hub) is slightly higher than the base of the hub.

Figure 9. Section through hub from original drawings showing hub cladding drainage system

- GRAEF reported that water leakage throughout the domes has historically been a problem and still remains an ongoing issue. GRAEF reported that water was observed sitting in the hub and not allowed to drain. They attribute this problem as due to the fact that the downspout rafter extends higher than the base of the hub (see Figure 9).
